## Building America Case Study Technology Solutions for New & Existing Homes

### Measure: Complete and Fully Aligned Air Barrier

**Project Name:**  
Bryce Deep Energy Retrofit

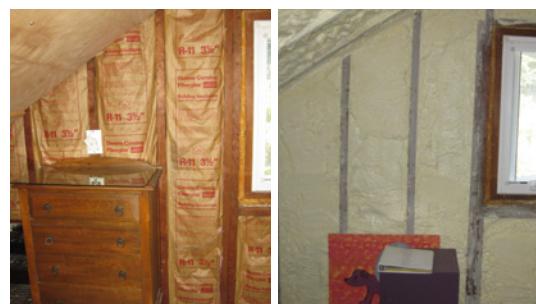
The side attics had a mixture of insulation types, including faced and unfaced fiberglass batt insulation (*left*). These were replaced with closed-cell spray foam on the exterior walls and roof deck to provide a complete and continuous air barrier (*right*), fully aligned with the vapor barrier. This reduced infiltration, mitigating the stack effect, which was pulling warm, moist air up into the attic.

To alleviate these issues, the homeowners worked with the Building America team to provide a complete, continuous air barrier that is fully aligned with the existing thermal and vapor barriers (in this case, the spray foam serves as both) by applying R-30 spray foam to the roof deck and exterior walls in the side attics. Before renovation, the relative humidity in the attic was approximately 60%, about 20% greater than the average interior relative humidity levels in this house. After the retrofit, the home has felt much cooler and less stuffy, according to the homeowner. The building air leakage also decreased from 6.6 air changes per hour at 50 pascals of depressurization (ACH50) to 4.3 ACH50, which is below the minimum ventilation limit for this home. Thus, in addition to air sealing, vents were added between the top attic and the second floor to increase air exchange and further prevent condensation, and a heat recovery ventilator (HRV) was added to provide adequate ventilation in the home. This additional ventilation, combined with a complete and fully aligned air barrier, helped solve this home's moisture problems while making the home much more efficient and comfortable.

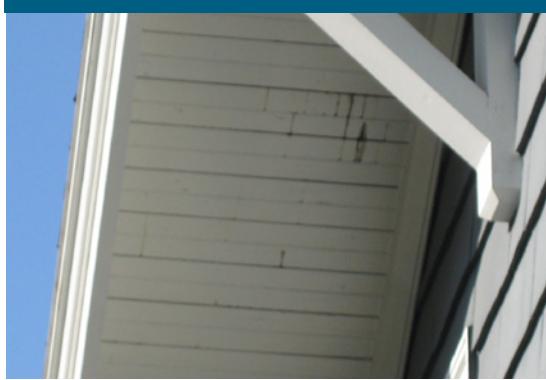
The top attic and part of the side attics in this historic four corner home had been insulated and air sealed with spray foam during a previous retrofit. However, other areas in the side attics had been insulated with fiberglass batt insulation, resulting in an incomplete air barrier. This made the insulation ineffective as a thermal barrier because the leaky side attics let large amounts of cool, outside air enter the attic in the winter. The spray foam and paper-faced batts, however, served as an excellent vapor barrier and condensing plane where warm, moist air

from inside the home would rise into the cool, side attic from the floors below and condense.

(top) Excessive humidity and condensation in the attic was causing unsightly staining and damage in the side attic spaces and on the eaves.

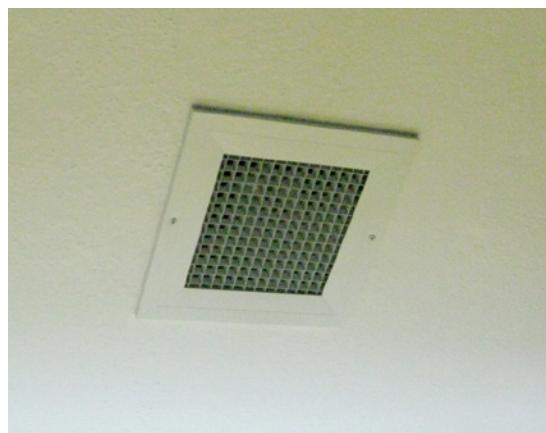
(bottom) The spray foam insulation in the top attic was trapping interior, warm air and moisture, significantly increasing the relative humidity levels. To relieve the excessive moisture build up and increase comfort on the second floor, passive transfer grilles were added between the second floor and the attic to increase air exchange between conditioned spaces, and an HRV was installed to increase overall ventilation in the home.
