Jackson, MS: Railroad Renovation

Window Retrofit: Jackson, MS

PNNL-SA-173314 • November 2022

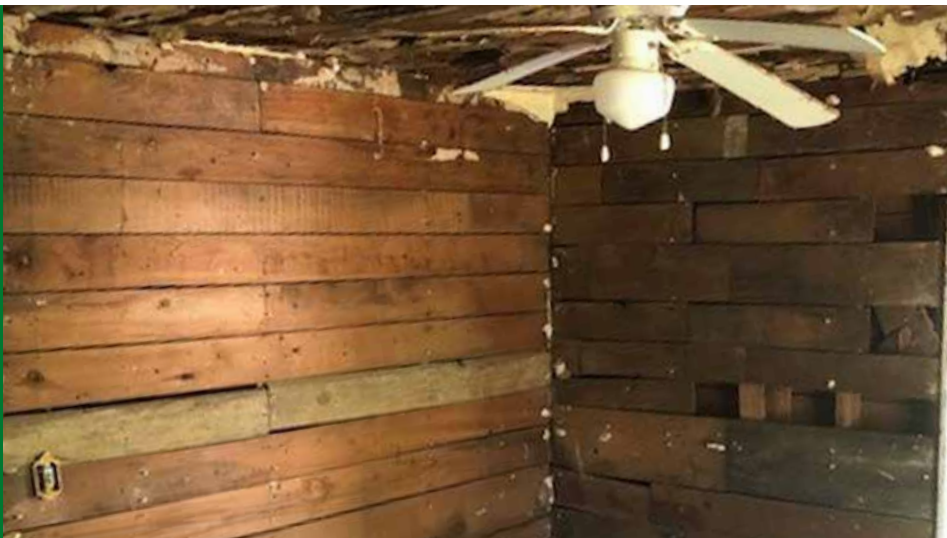
The home had irregular board sheathing attached to the inside face and outside face of the wall studs which were not evenly spaced. Wallpaper was installed on the ceiling possibly to serve as a vapor barrier over the board sheathing on the ceiling. The top and bottom plates consisted of several small pieces of 2x4s. The floor joists were irregular and were resting on stacks of bricks or concrete block, providing a low and unstable crawl space.

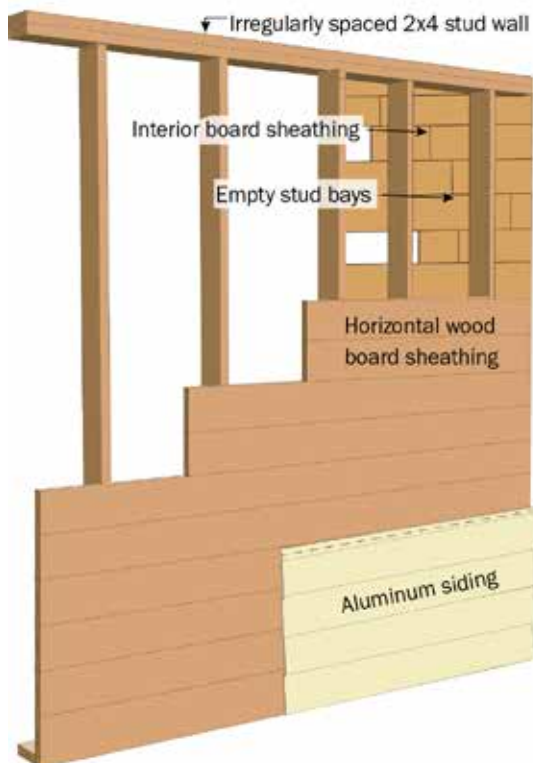
Jackson	Pre-Retrofit	Post-Retrofit
Vintage	1955	2022
Wall Assembly	Aluminum siding stapled to studs. Stud framing inconsistently spaced in walls and ceiling. 1x6 board sheathing on interior and exterior of studs. On exterior aluminum siding was stapled to board sheathing, no house wrap. On interior, the boards were covered with wall paper and drywall or paneling.	Removed old siding and interior board sheathing, drywall, and paneling. Kept exterior board sheathing but where damaged replaced with OSB. Repositioned studs for 2x4 at 16-inch on-center spacing. Installed house wrap, rigid foam with taped seams and new vinyl siding. On interior, filled wall cavities with fiberglass batts then covered with new drywall.
Windows	11 original windows: some were aluminum-framed single- or double-pane, some were single-pane wood framed.	Triple-pane vinyl-frame windows installed after house wrap and rigid foam were installed.

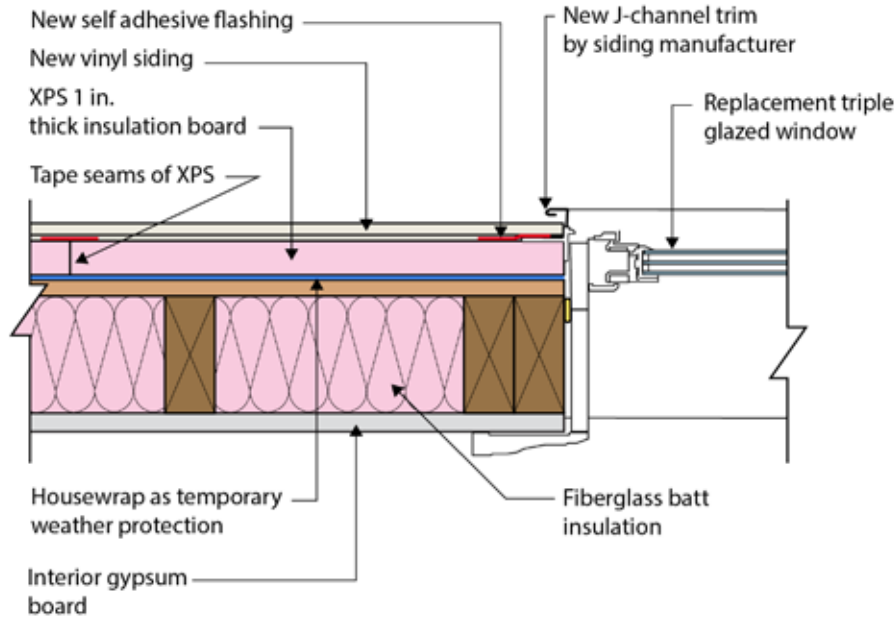
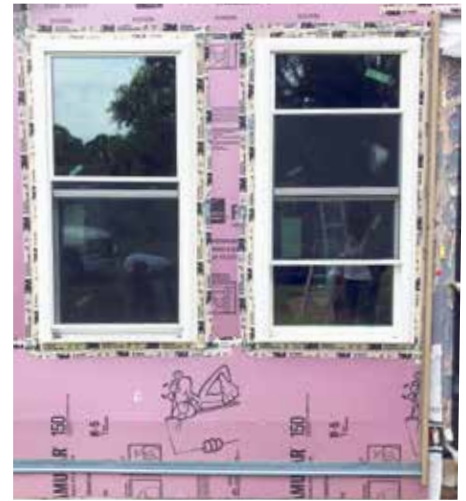
Jamb Detail

The original windows, an assortment of single- and double-pane metal- and wood-framed windows were in bad shape. All were replaced with triple-pane vinyl-framed windows for energy efficiency and sound abatement. Note, at the bottom of the window, pan flashing is typically installed beneath the sill but tape is not installed over the sill flange.

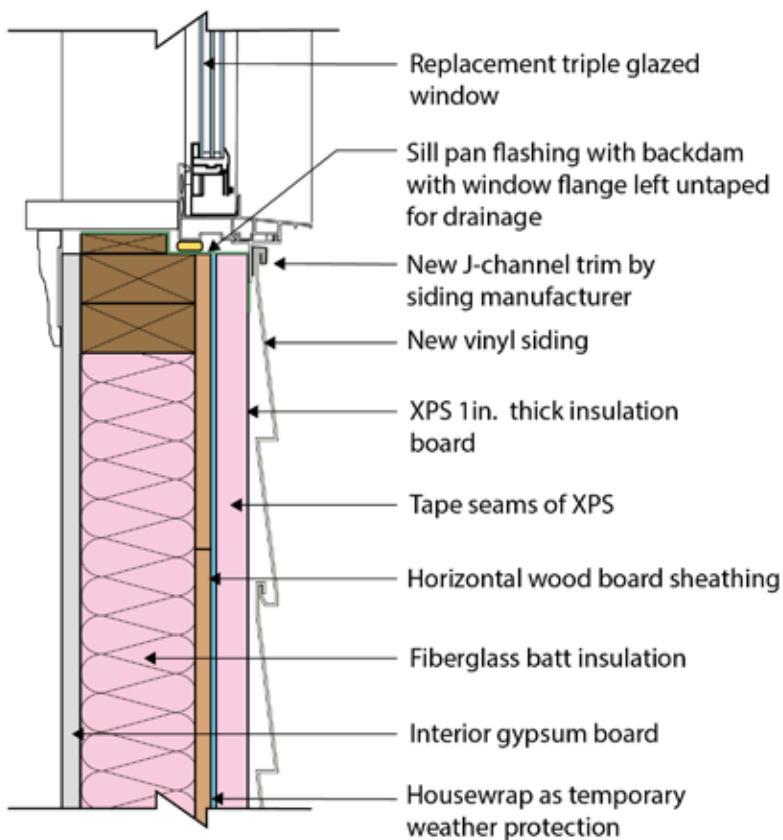
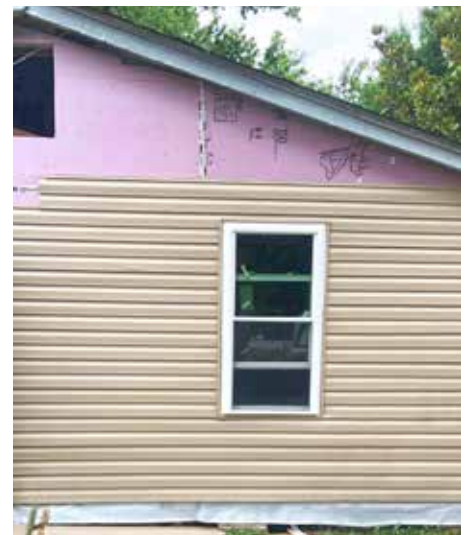
Sill Detail

New vinyl siding was installed over the windows which were installed over new house wrap and 1 inch of rigid EPS.
