# Window Retrofit: Jackson, MS

- Name: Railroad Renovation
- Location: Jackson, Mississippi  
Layout: 3 bdrm, 1 bath, 1 fl, 820 ft<sup>2</sup>
- Climate: IECC 3A, hot-humid
- Year Built: 1955
- Retrofit Completed: June 2022

## Jackson – Windows

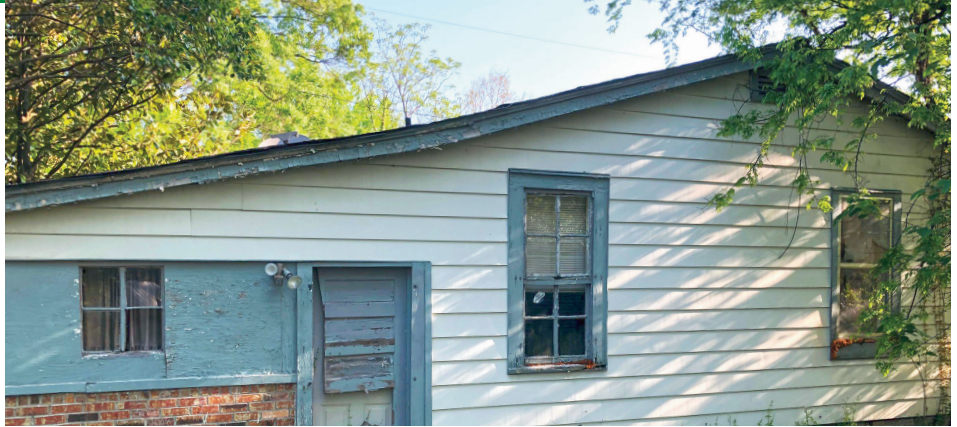
A mix of aluminum-framed single- or double-pane and single-pane wood-framed windows

This 1950's bungalow in Jackson, Mississippi, needed extensive renovation throughout, including the windows, which were a mix of single-hung wood-framed and fixed metal-framed single-pane clear-glass windows. Some were missing glass, none of the framing was true, and extensive water damage was evident around the frames and sills of most of the windows. The U.S. Department of Energy-supported retrofit included replacing the old windows with ENERGY STAR Most Efficient triple-pane windows. The new windows have vinyl frames, an argon gas fill between the panes, and two layers of low-emissivity coating which together provide an insulation value of  $U=0.20$  and a solar heat gain coefficient of 0.18. The windows came with tempered glass, which the big box supplier recommended given the possibility of hurricane-related storms in the region. In addition to the significant improvement in energy efficiency, the windows will also provide significant sound abatement, an important benefit given that the home is located 100 yards from an active railroad track.

ENERGY STAR Most Efficient triple-pane vinyl-framed windows

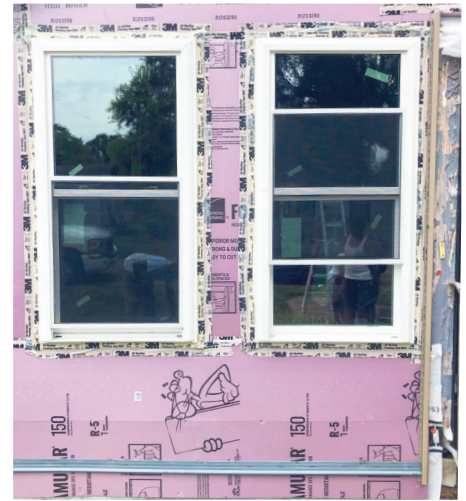
The original windows, an assortment of single- and double-pane metal- and wood-framed windows were in bad shape. All were replaced with triple-pane vinyl-framed windows for energy efficiency and sound abatement. Note, at the bottom of the window, pan flashing is typically installed beneath the sill but tape is not installed over the sill flange.

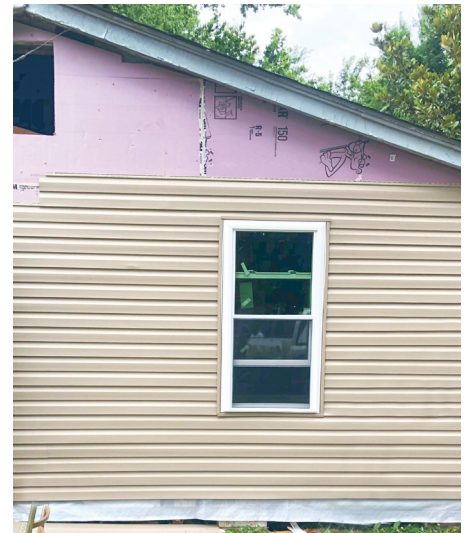
New vinyl siding was installed over the windows which were installed over new house wrap and 1 inch of rigid EPS.
