## Jackson, MS: Railroad Renovation

This 820-ft<sup>2</sup> home built in Jackson, Mississippi, in 1955 needed extensive renovation in addition to new siding and windows.

# Window Retrofit: Jackson, MS

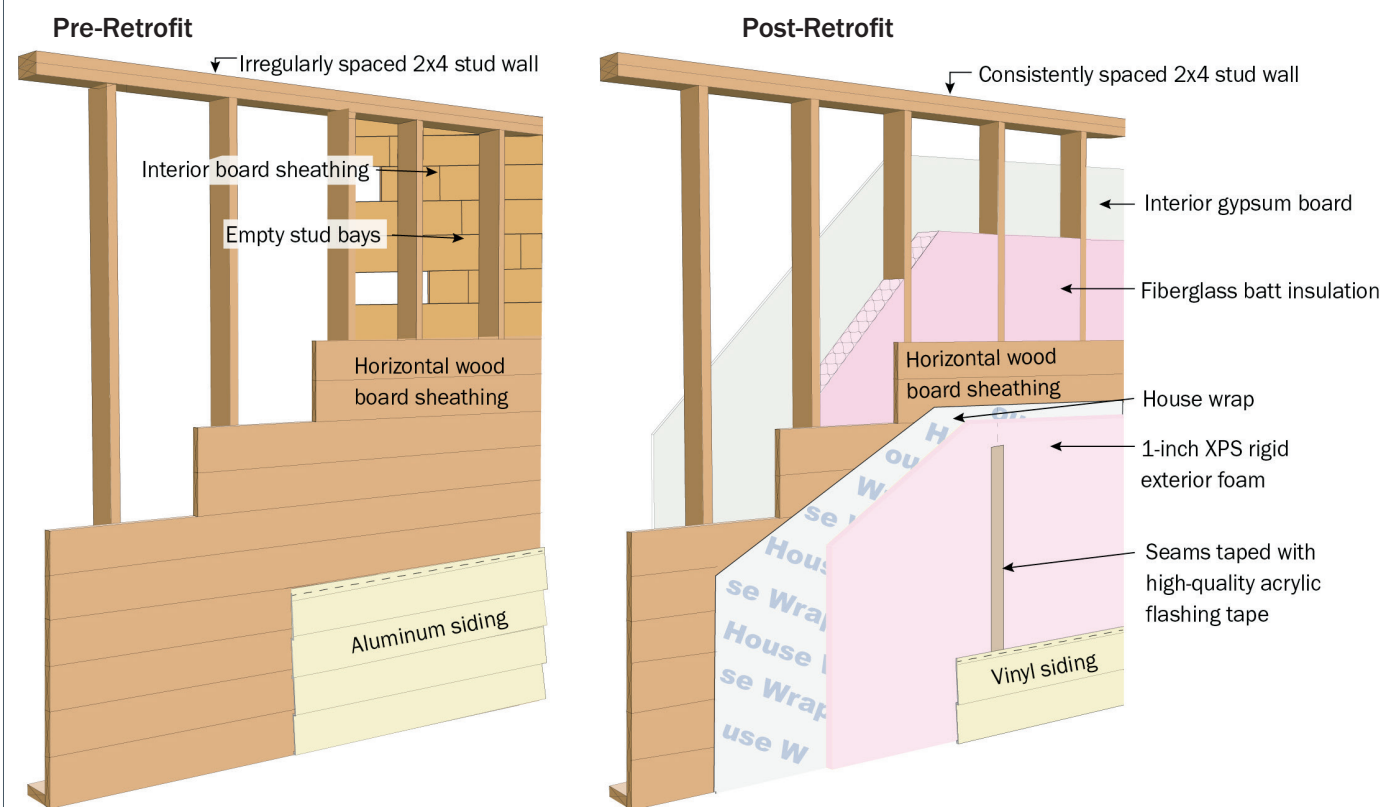
### Jackson Pre- and Post-Retrofit Wall Assembly Details

Jackson	Pre-Retrofit	Post-Retrofit
Vintage	1955	2022
Wall Assembly	Aluminum siding stapled to studs. Stud framing inconsistently spaced in walls and ceiling. 1x6 board sheathing on interior and exterior of studs. On exterior aluminum siding was stapled to board sheathing, no house wrap. On interior, the boards were covered with wall paper and drywall or paneling.	Removed old siding and interior board sheathing, drywall, and paneling. Kept exterior board sheathing but where damaged replaced with OSB. Repositioned studs for 2x4 at 16-inch on-center spacing. Installed house wrap, rigid foam with taped seams and new vinyl siding. On interior, filled wall cavities with fiberglass batts then covered with new drywall.
Windows	11 original windows: some were aluminum-framed single- or double-pane, some were single-pane wood framed.	Triple-pane vinyl-frame windows installed after house wrap and rigid foam were installed.

For the finished wall assembly, Nichols chose to re-position the 2x4 studs to a consistent 16 inches on-center, kept the exterior board sheathing but replaced with OSB where the boards were damaged, then covered the boards with house wrap, 1 inch of XPS rigid with taped seams, and vinyl siding. He had originally planned to use fiber cement but was concerned about the weight as vinyl siding could be nailed to the board sheathing whereas fiber cement would need to be nailed through to the studs. He also liked the inherent drainage gap behind vinyl siding and felt it was more forgiving of house movement, noting that with an active railroad track within 100 yards of the home, there would always be ground movement at the site. On the interior, Nichols removed board sheathing, filled the stud bays with fiberglass batts, and installed drywall.

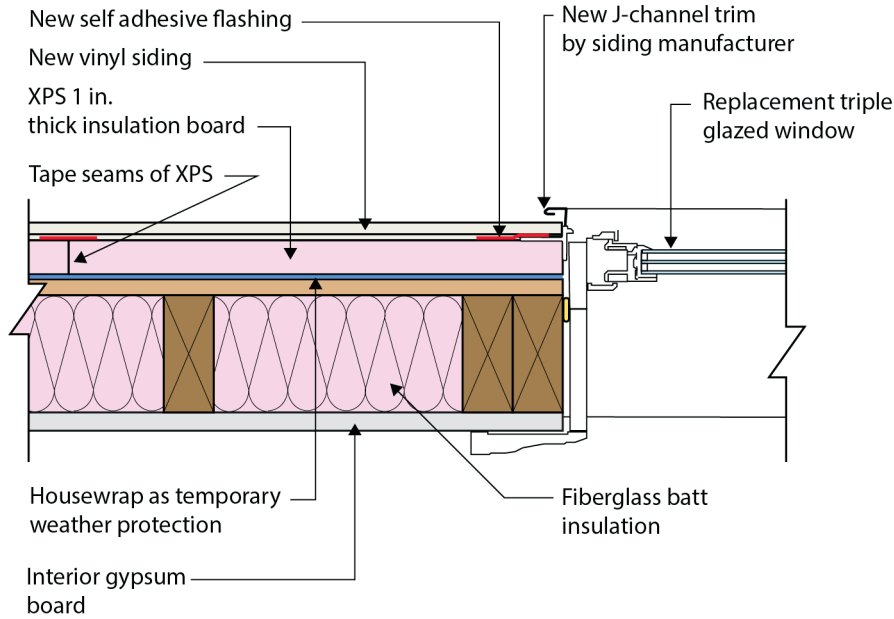
## Jamb Detail

The original windows, an assortment of single- and double-pane metal- and wood-framed windows were in bad shape. All were replaced with triple-pane vinyl-framed windows for energy efficiency and sound abatement. Note, at the bottom of the window, pan flashing is typically installed beneath the sill but tape is not installed over the sill flange.

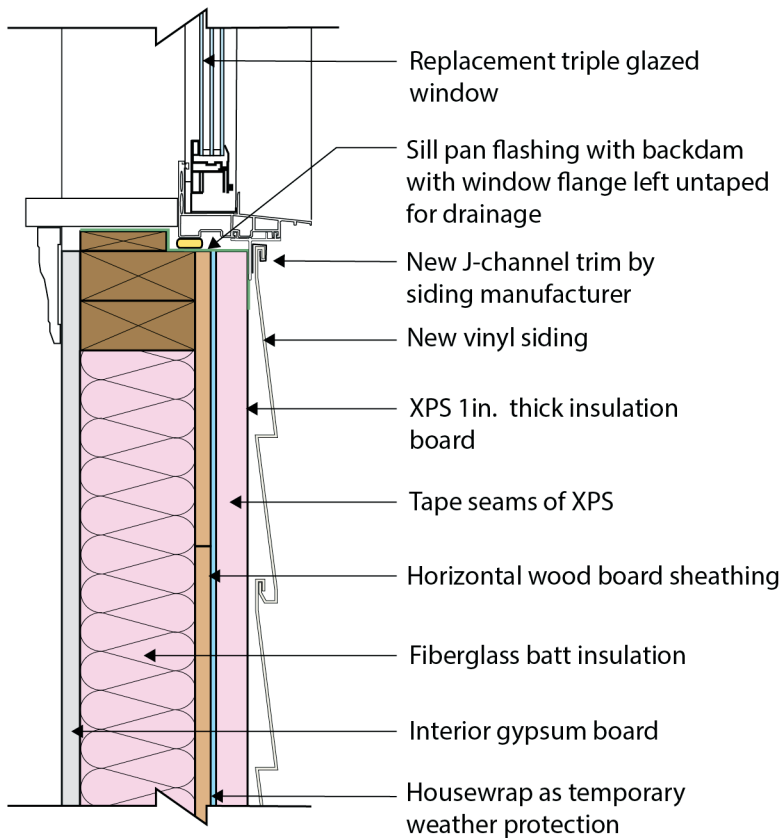
## Sill Detail

New vinyl siding was installed over the windows which were installed over new house wrap and 1 inch of rigid EPS.
