Bellingham, WA: Cedar Siding Retrofit

Window Retrofit: Bellingham, WA

PNNL-SA-173314 • December 2022

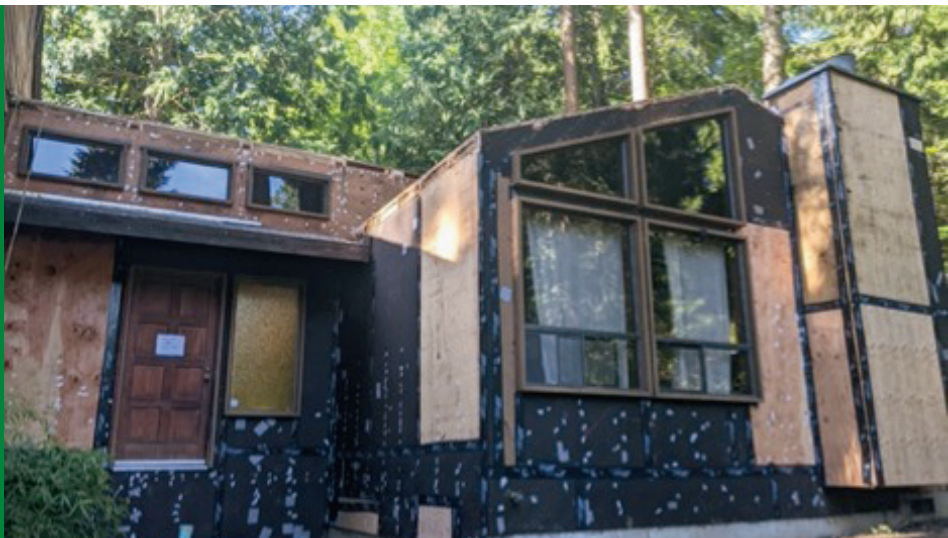
When Welch and Lett removed the siding, they found extensive damage. The cedar siding was installed diagonally on several walls and grooves in the siding directed the surface water runoff into the trim joints, where it eroded the trim, while wet debris from overhead trees collected in the corners and exacerbated rotting of the siding. Other areas of the home lacked overhangs and water was flowing directly behind the siding due to lack of drip edge flashing and a poorly designed fascia. The poorly flashed cedar-covered chimney had extensive damage as did the entry deck, which was installed tight to the siding with no drainage gap or effective cap flashing. Splash back and build up of pine needles and cedar tree droppings along the wall was rotting the siding next to the deck as well. A poorly placed dryer vent under a kitchen window bump-out was causing rot below the window while the top of the bump-out was rotting due to missing trim. Lack of a drained air gap behind the siding contributed to its inability to dry out.

The entryway deck had been attached directly to the cedar siding with no drainage gap or ledger board, leading to extensive rotting. The “more mold than wood” decking was removed and the damaged siding was pulled off revealing wet sheathing underneath. There was also extensive moisture damage around the chimney and rotten fascia along the roofline due to missing flashing.

After removing and saving whatever cedar boards could be salvaged, removing the windows, and removing and replacing any rotted plywood sheathing, Lett installed self-adhered water-resistant membrane over the walls to provide both a moisture barrier and air sealing. Over this Lett installed 2-inch-thick cork exterior insulation. Furring strips of borate-treated 2-inch-by-8-foot plywood strips were installed to provide a drainage gap behind the cedar, fiber cement, and metal siding. For this home, the siding contractor installed the cork layer first, then did a second pass around the house to install the furring strips. He felt that on future installs he could save time by installing the first course of cork, then the furring strips, then tucking additional rows of cork, which comes in roughly 2x3-ft pieces, behind the furring strips and attaching both with the same fasteners as they work up the wall.

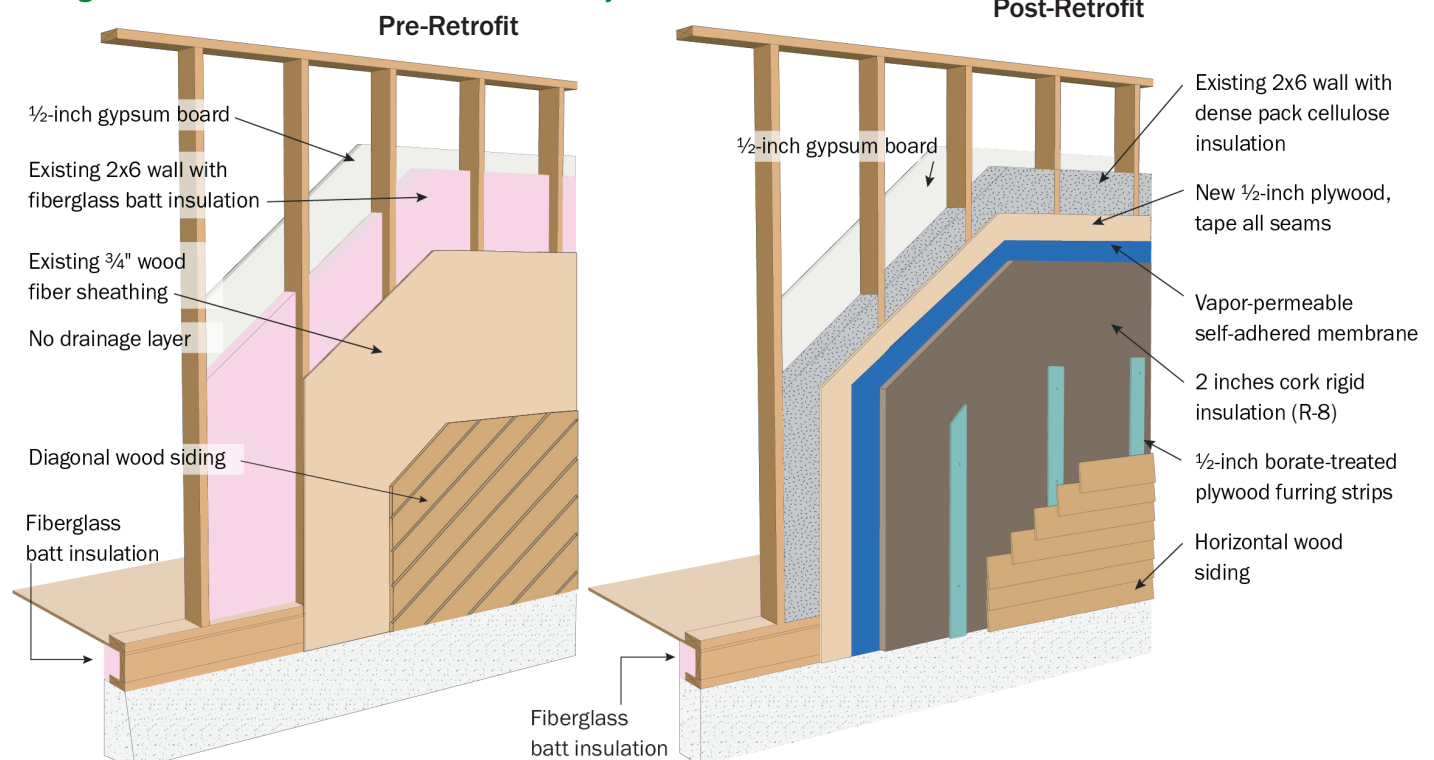
Bellingham Pre- and Post-Retrofit Wall Assembly Details

| Bellingham | Pre-Retrofit | Post-Retrofit |
|---|--|---|
| Wall Assembly | Split-level 2-story, 2x4 16-inch on-center walls, with some rockwool and fiberglass batts, plywood or asphalted fiberboard sheathing, tar paper. Siding is the original shiplapped cedar wood siding, stained and installed on diagonal with a lot of rot. | Kept drywall, 2x4s, rockwool batts, plywood. Replaced tar paper with self-adhered, vapor-permeable water-resistive membrane. Added 2 inches cork exterior insulation and ¾-inch borate-treated plywood furring strips for drainage gap. Siding is re-used flipped cedar, fiber cement, and metal at areas with no overhang. |
