Investigating Solutions to Wind Washing Issues in Two-Story Florida Homes, Phase 2

C. Withers and J. Kono

*Building America Partnership for Improved
Residential Construction*

April 2015

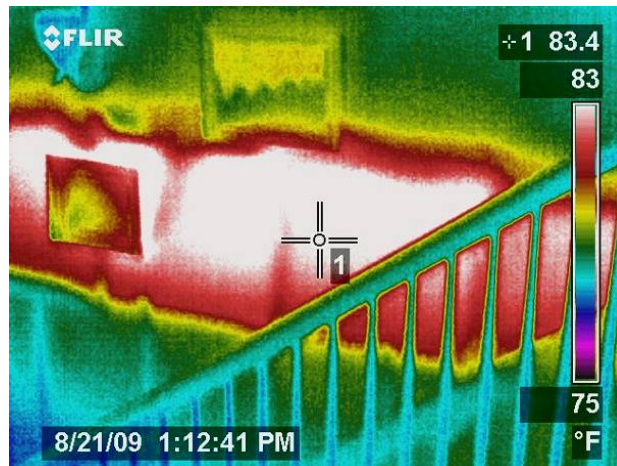
Figure 17. Summer IR image shows where hot attic air has penetrated into the floor cavity that lies behind the stairwell wall. The wall surface temperature at the floor cavity interface was 83°F compared to 77°–78°F room air temperature.

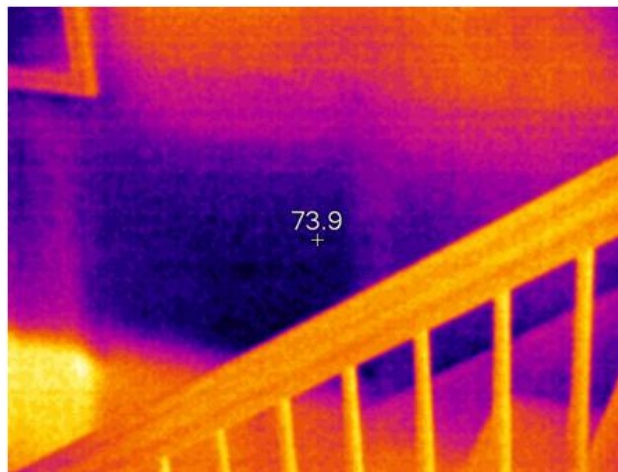
Figure 18. Winter IR image shows where cold outdoor air has penetrated into the floor cavity that lies behind the stairwell wall. The wall surface temperature at the floor cavity interface was 73.9°F, about 1.5°F colder than the room air temperature. Overnight low outdoor temperature was about 44°F several hours prior to the image with calm wind conditions.

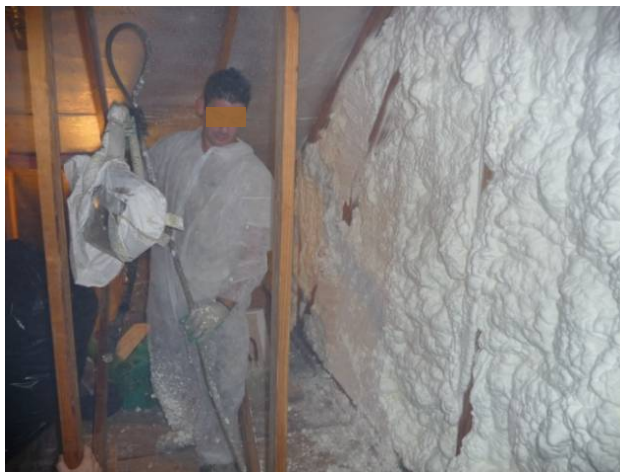
Figure 33. Foam insulation was used to seal the attic-to-floor cavity opening and insulate the knee wall above the floor cavity opening in Phase 1 House H16B.

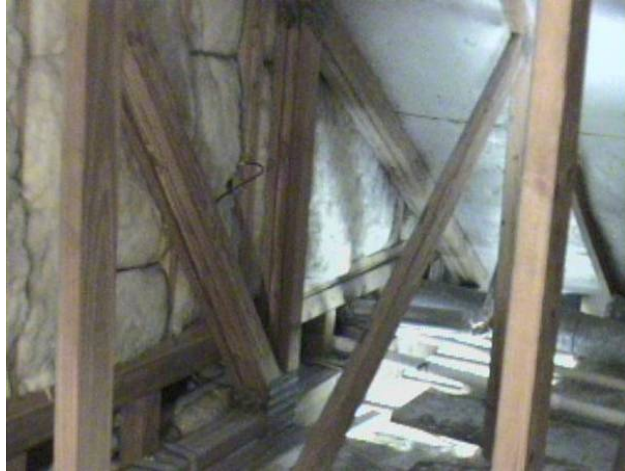
Figure 34. Floor cavity opening and knee wall can be seen in House H16B prior to foam insulation application.

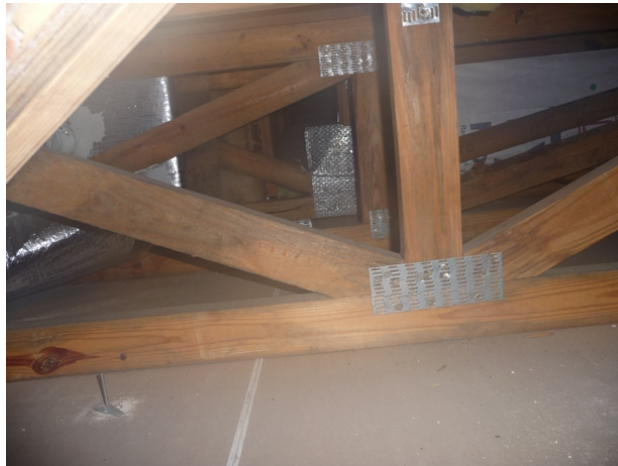
Figure A3. Looking from east attic space into open floor cavity (view toward the west)

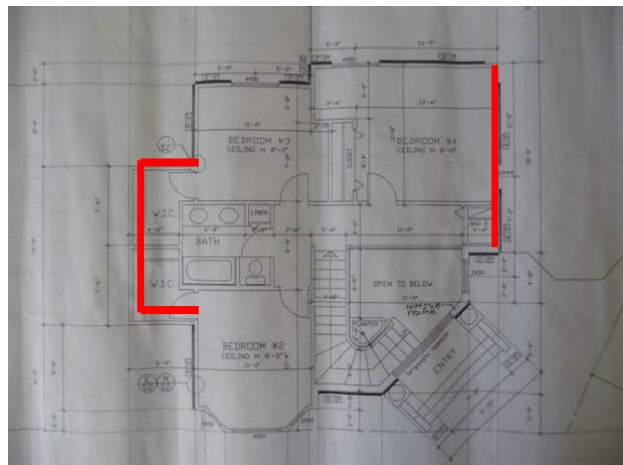
Figure A10. Second-story floor plan. Red lines indicate areas of openings from attics into floor cavities.

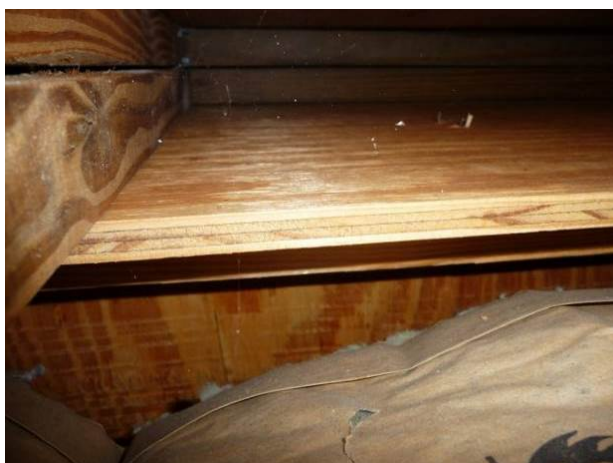
Figure A11. View looking up into a vacant wall cavity from within the east attic shows no insulation in this wall next to a walk-in closet.

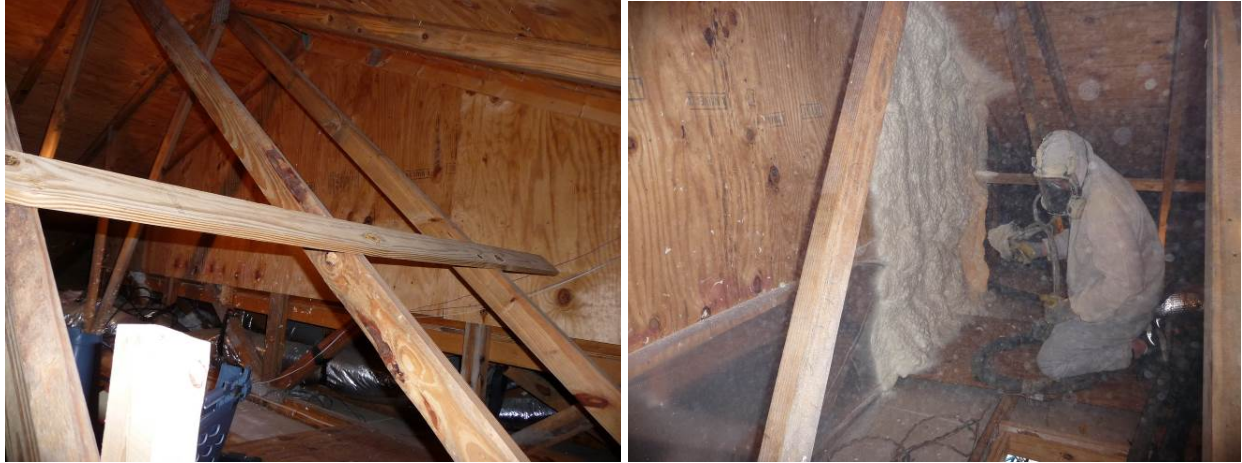
Figure A12. East side of floor cavity and knee wall before and during repair with spray LDF.

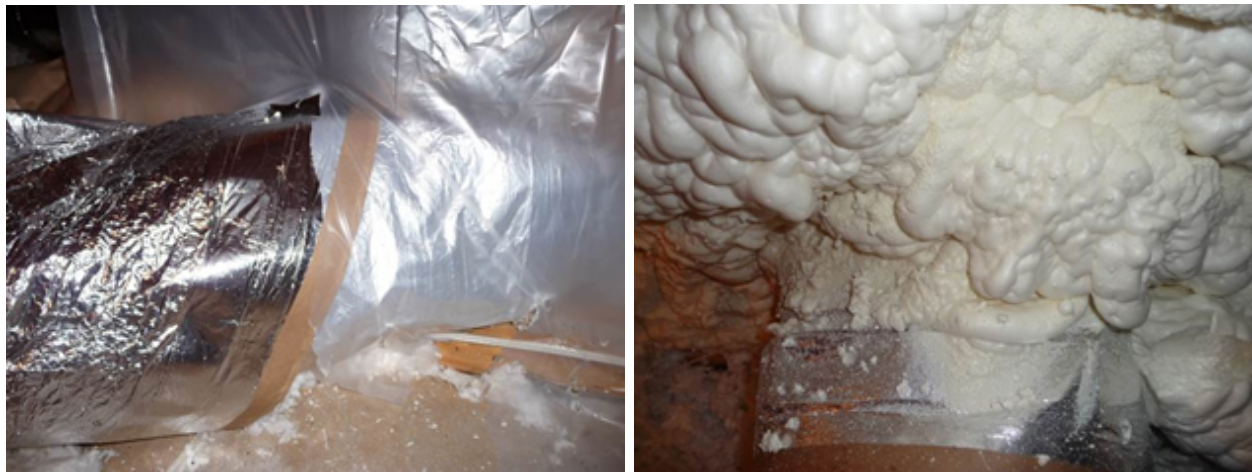
Figure A13. Photo on left was taken during the preparation to protect cold air supply duct with an insulating wrap having vapor barrier on outside. Photo on right is a view over top of duct after the wrap was carefully attached and foam was applied.

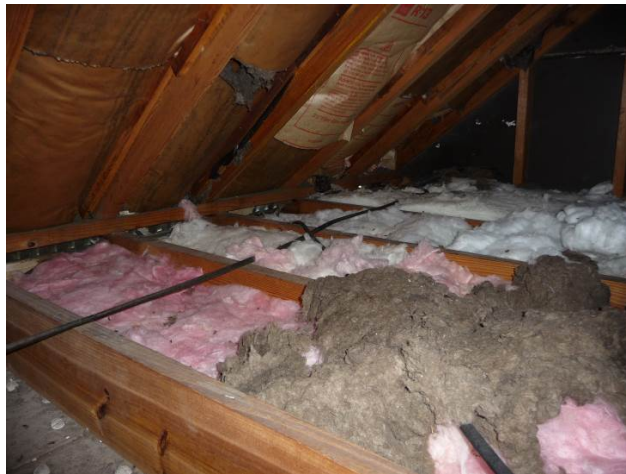
Figure A16. Pieces of old batt insulation, which have fallen from the roof deck above, can be seen in one area on the attic floor.

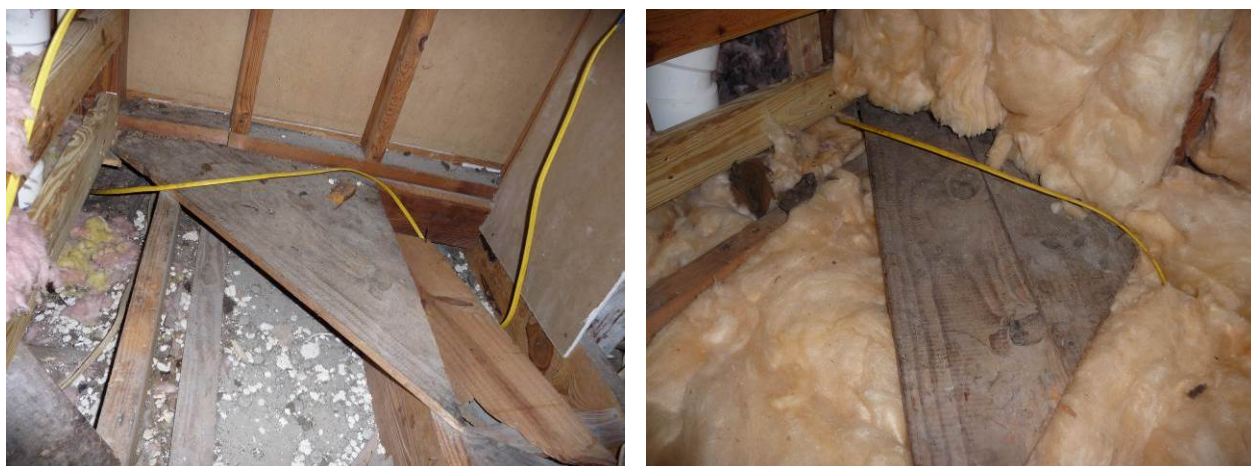
Figure A18. A section of unsealed and uninsulated floor cavity and knee wall in left photo and during repair with R-30 kraft-faced batt insulation installed in photo on the right.

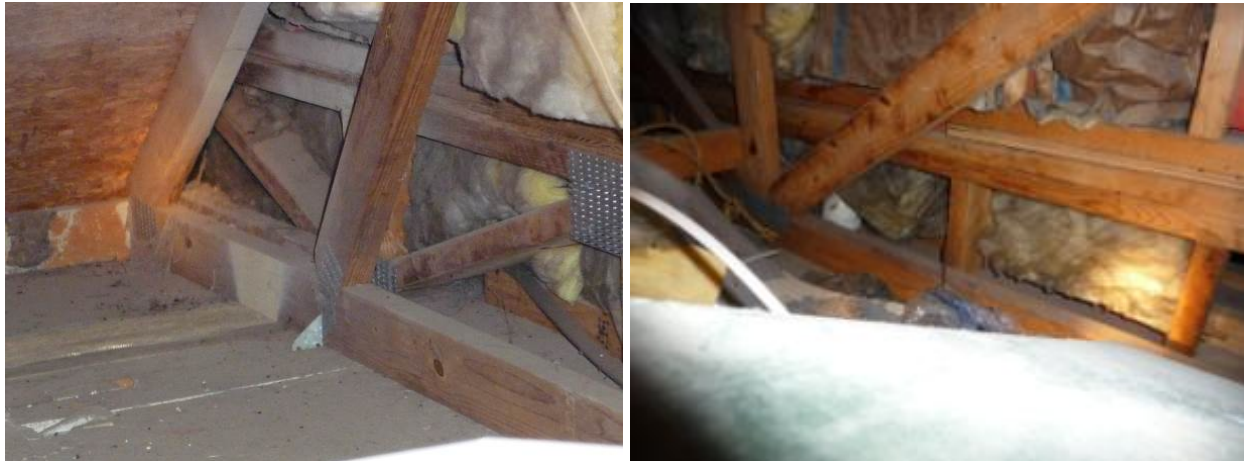
Figure A21. At left is a floor cavity section where existing batts do not seal the space. At right is another section with compressions and voids in the batt.

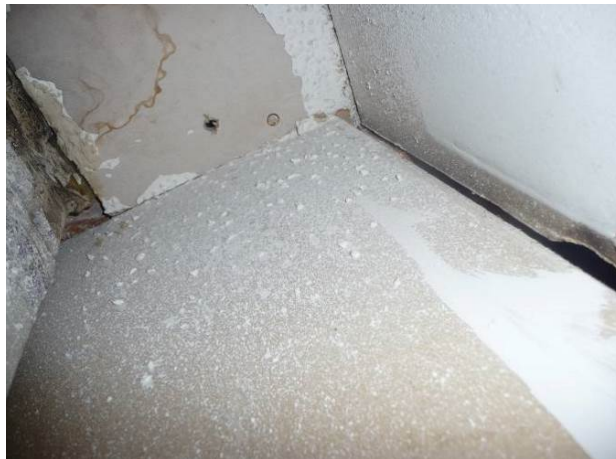
Figure A23. View of AHU closet ceiling. The closet, which operates at negative pressure because it is a return plenum, is very leaky to the second-story floor cavity as a result of unfinished drywall wall at the corner and large gaps in the ceiling. Some areas of air leakage were identified by squeezing a digital camera into tight areas between the AHU and the wall.

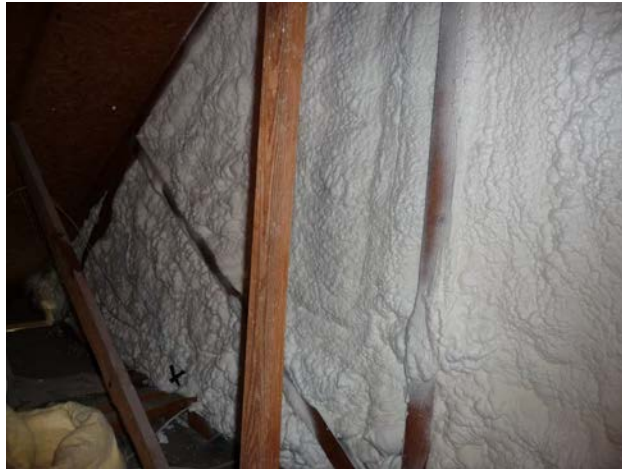
Figure A24. Finished view of foam sealed and insulated floor cavity and knee wall of House H37M

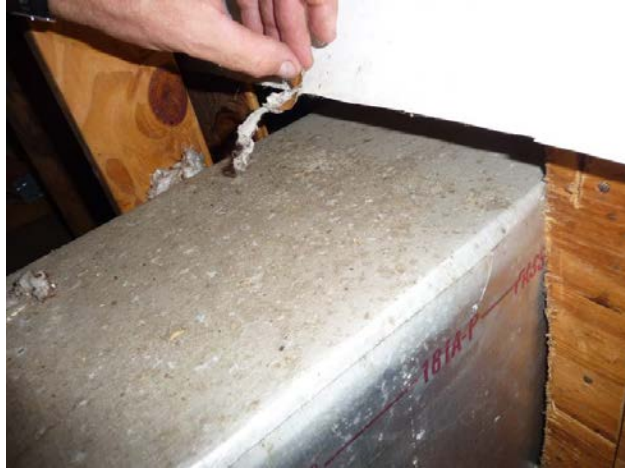
Figure A26. Air flows from floor cavity into west attic area pushing paper away from floor cavity leak toward the attic space. This leak is a complementary pathway to larger floor cavity leakage in the east attic.

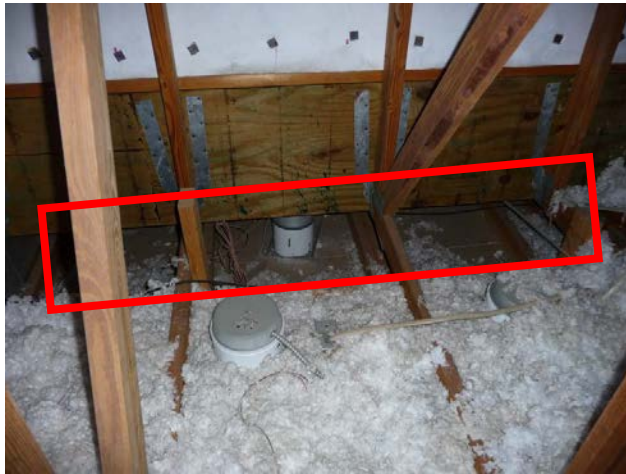
Figure A27. View of pathway from the garage (east) attic into a floor cavity, which results primarily from a dropped ceiling over the kitchen.

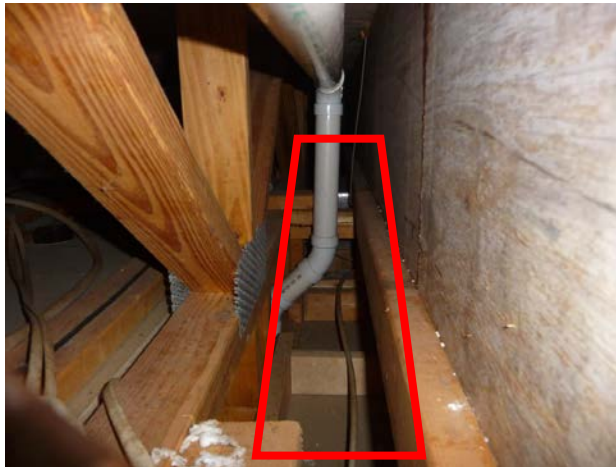
Figure A30. View of the inside floor cavity at corner leak in preceding figure. A large area of the floor cavity is effectively covered by well-placed plywood, but air circumvents this from under the dropped ceiling area at the red box.

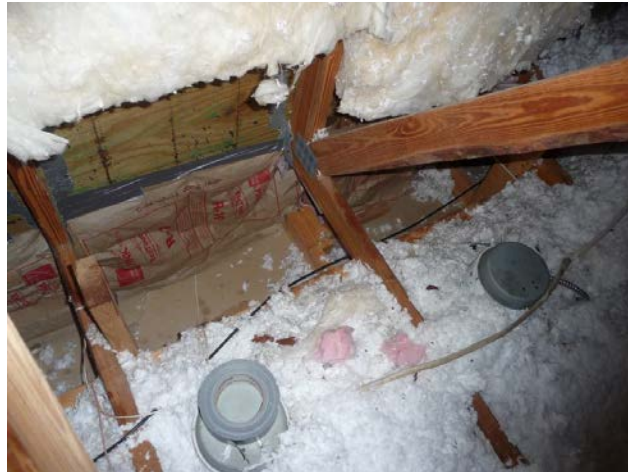
Figure A31. Sealing vertical plane of pathway with paper mechanically fastened and adhered to solid plywood above and adhered to the drywall ceiling below. Duct tape is not a lasting seal, but is used to reinforce the paper edge and provide temporary support during final placement.

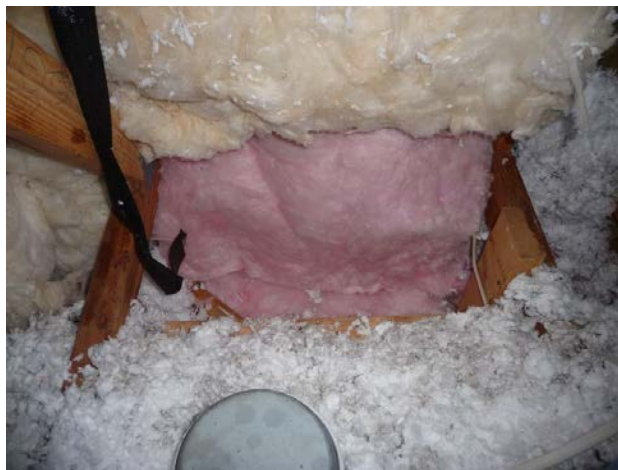
Figure A32. Section of completed repair with R-19 batt insulation fiberglass side out placed against the initial section of insulation in the previous figure. This is done to provide code-required fire ignition protection of the paper facing.

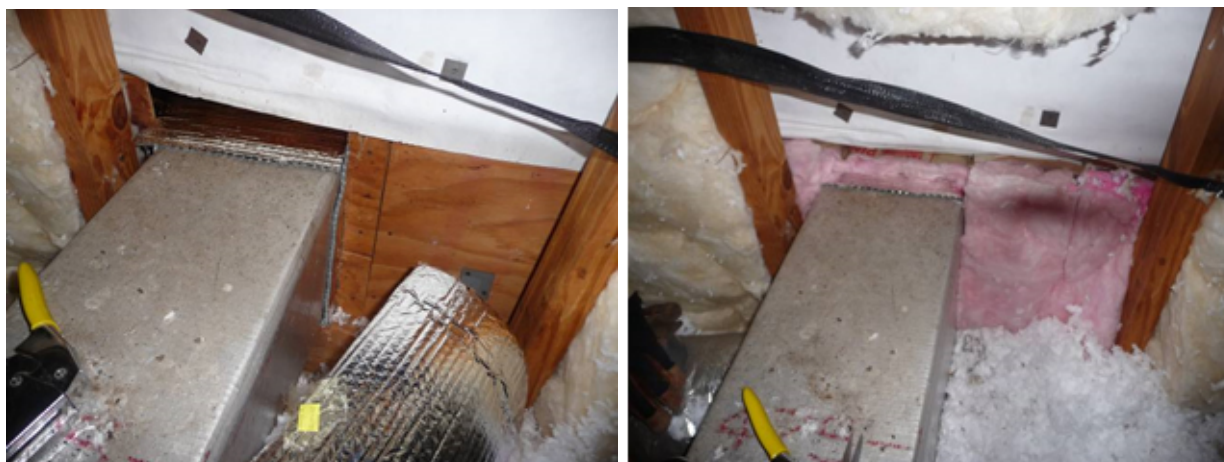
Figure A33. Repair in the west attic at duct penetration starts with application of a thin insulated vapor barrier placed against the cold supply duct. Then, batt insulation was placed against the vapor barrier.

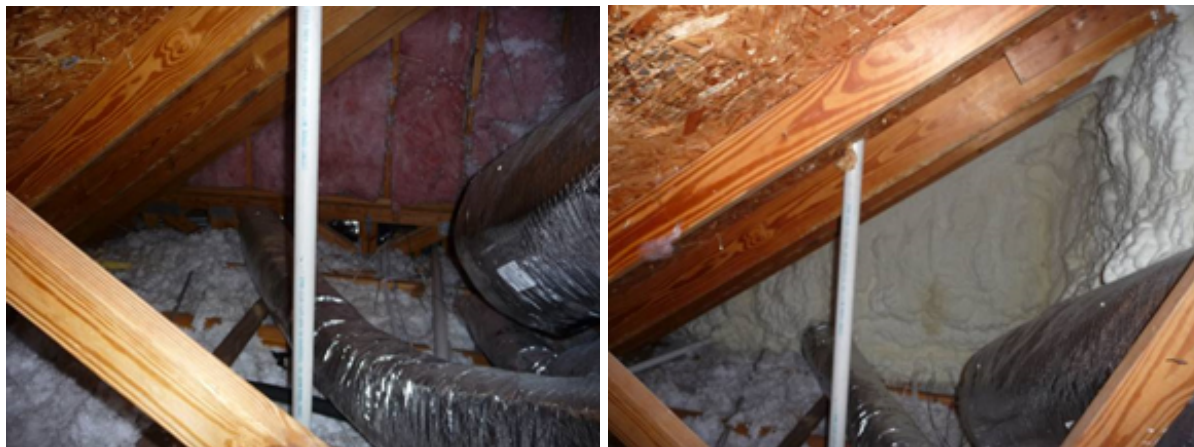
Figure A35. East side of floor cavity and knee wall before and after repair

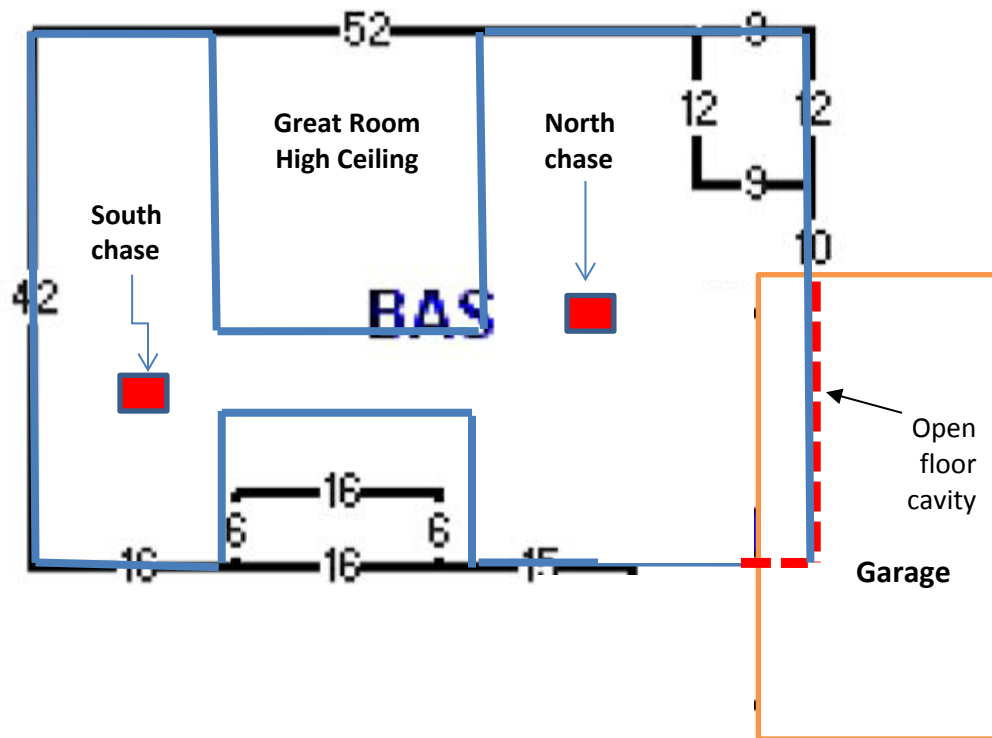
Figure A37. Floor plan layout of House H47W showing leakage areas at red dashed line and red boxes. The floor plan overlay of the second-floor area is outlined in blue lines.

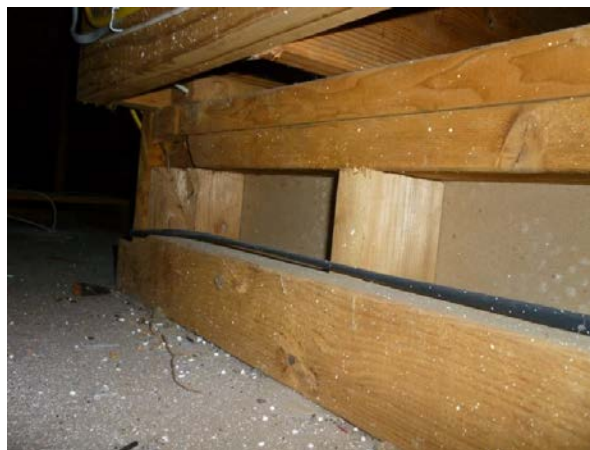
Figure A38. Second floor has a cantilever section inside the garage attic that resulted in a pathway about 3 in. wide by about 18 ft long.

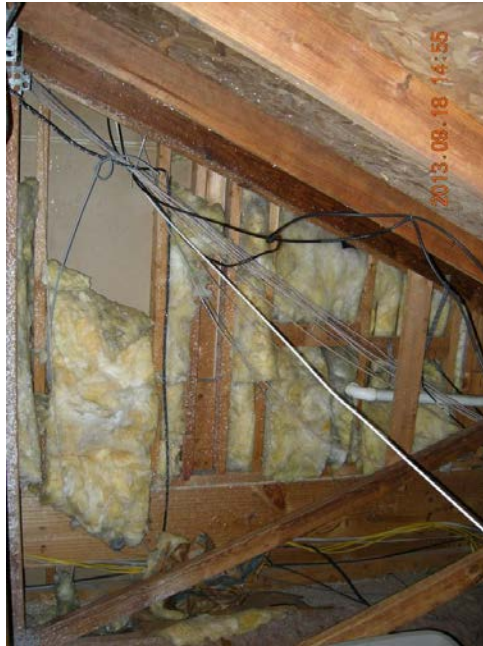
Figure A39. Garage knee wall with R-11 insulation in very poor condition. The irregular framing pattern and numerous wires make it more difficult to adequately insulate with fiberglass batts.

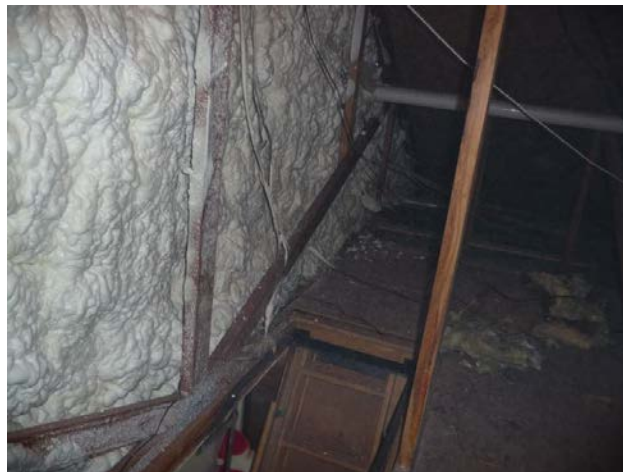
Figure A40. Floor cavity and knee wall after repair in garage attic

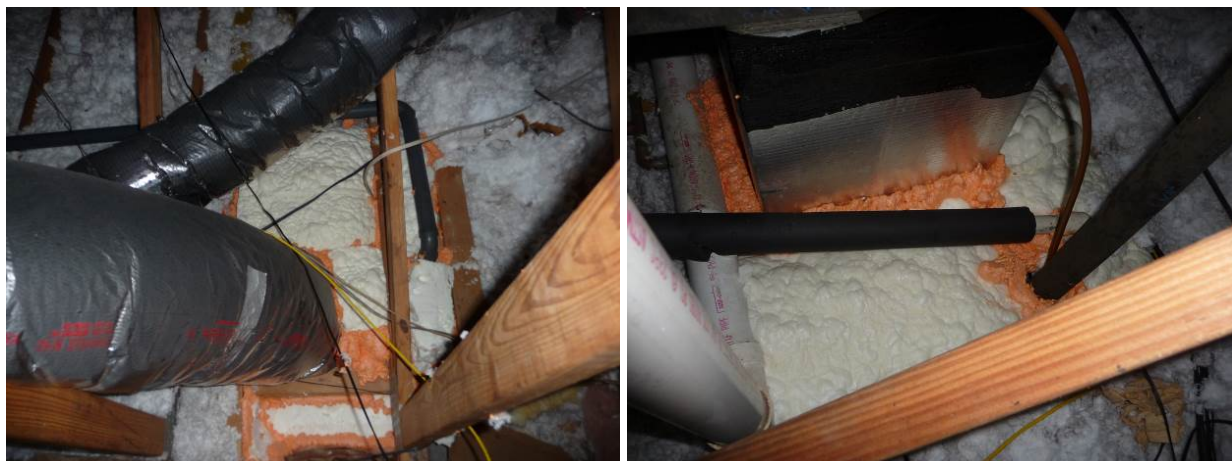
Figure A41. Vertical duct chase openings in second-story attic after sealing with foam

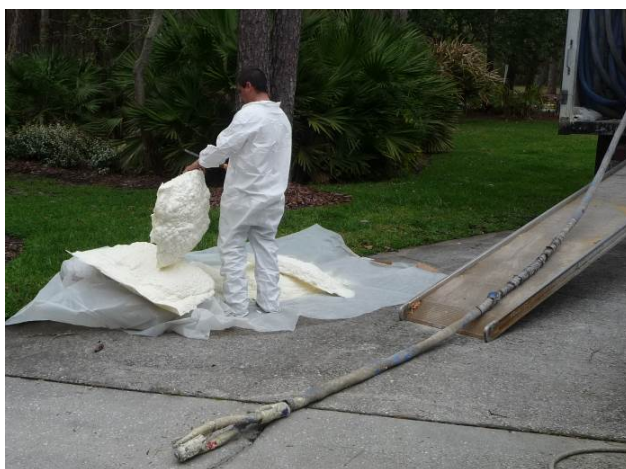
Figure A42. Foam plugs used to seal the second-story attic chase pathways were created outdoors, then easily carried up to the repair site.
