## Project Home

- Name: Slump Block Home
- Location: Phoenix, Arizona
- Layout: 3-bdrm, 1 bath, 1 fl, 1,980 ft<sup>2</sup>
- Climate: IECC 2B, hot-dry
- Year Built: 1949
- Retrofit Completed: July 2021

## Phoenix – Windows

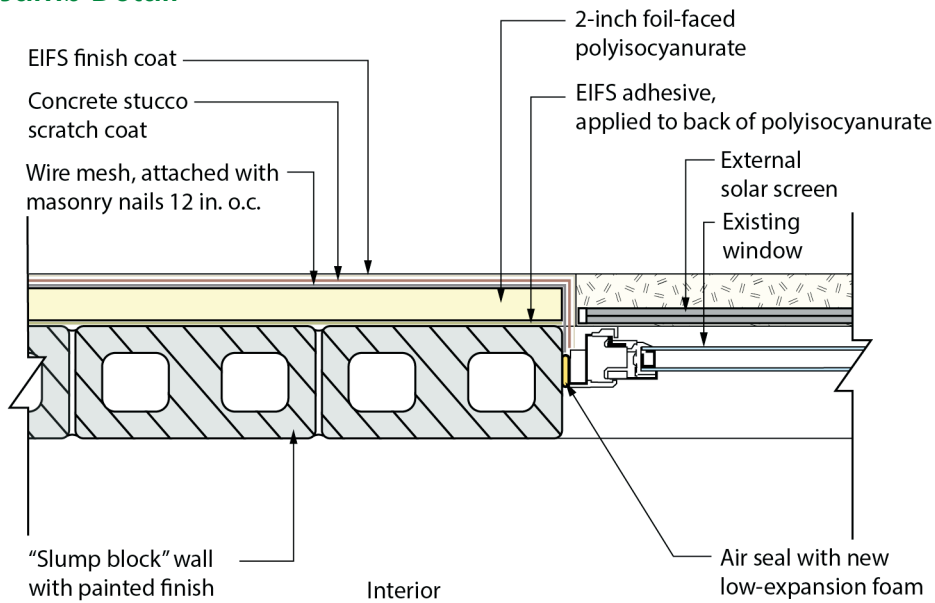
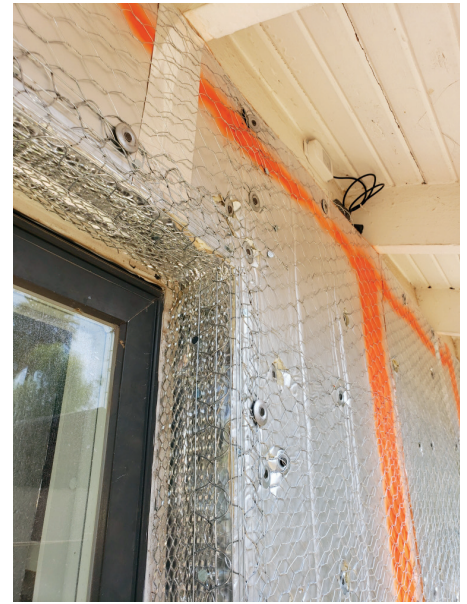
## Jamb Detail

Stucco lath wraps around the windows and covers the 2 inches of foil-faced polyisocyanurate rigid foam that was installed over the original concrete block walls.

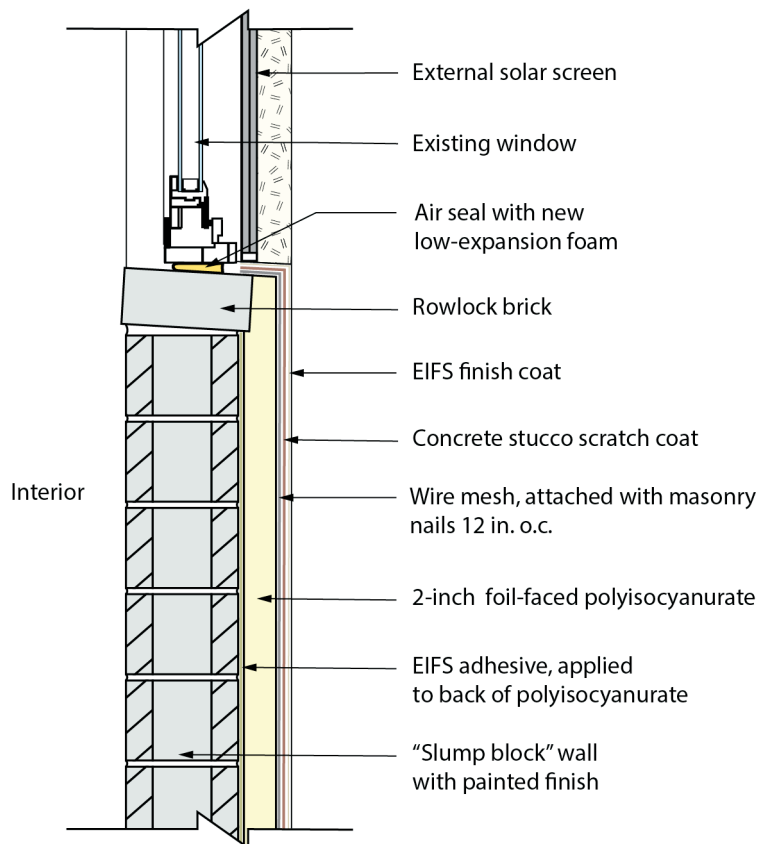
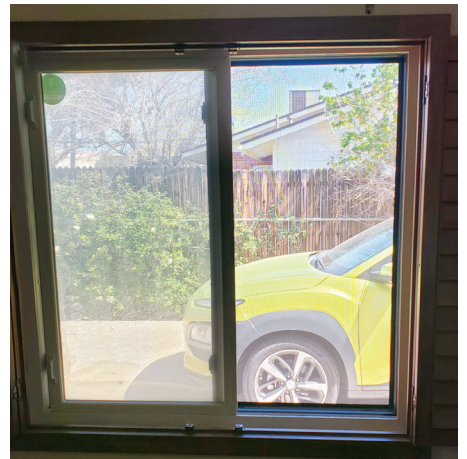
## Sill Detail

Solar screens were attached to the exterior of the window frames with Velcro-like attachments to reduce solar heat gain and views into the home while allowing views out.
