Phoenix, AZ: Insulating Concrete Block Walls

Rigid foam exterior insulation and solar screens were among the energy-saving retrofits to this 1950s concrete block home in Phoenix.

Project Home

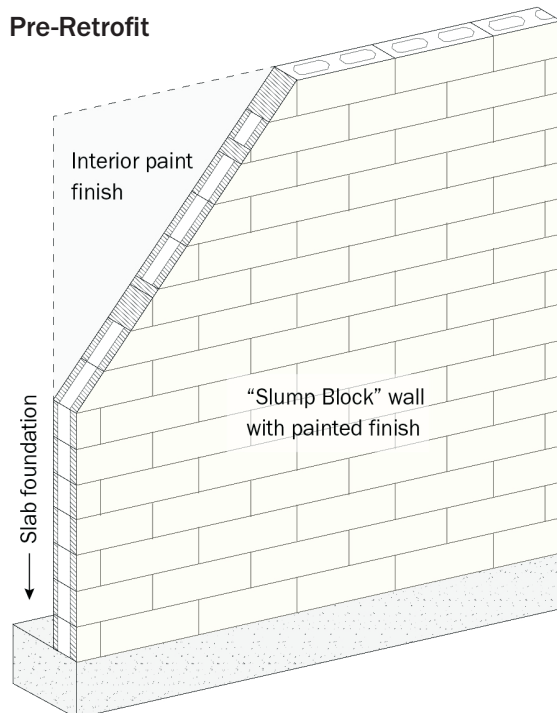
Pre-Retrofit

The original home had no insulation, no exterior siding, no interior framed wall, and no drywall. The entire wall assembly consisted of uninsulated concrete block that was painted on the interior and exterior. In this retrofit, 2 inches of foil-faced polyisocyanurate rigid foam was added to the exterior of the home then covered with metal lath and two-part stucco. The added insulation greatly improved the comfort of the home, especially on the east side of the home where a driveway reflected heat into the home.
