Phoenix, AZ: Insulating Concrete Block Walls

Project Home

- Name: Slump Block Home
- Location: Phoenix, Arizona
- Layout: 3-bdrm, 1 bath, 1 fl, 1,980 ft²
- Climate: IECC 2B, hot-dry
- Year Built: 1949
- Retrofit Completed: July 2021

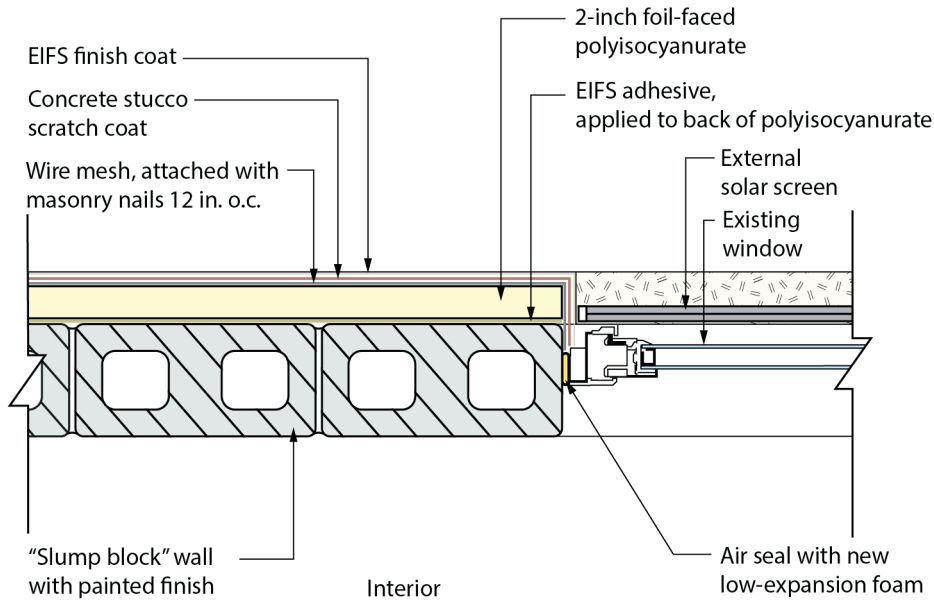
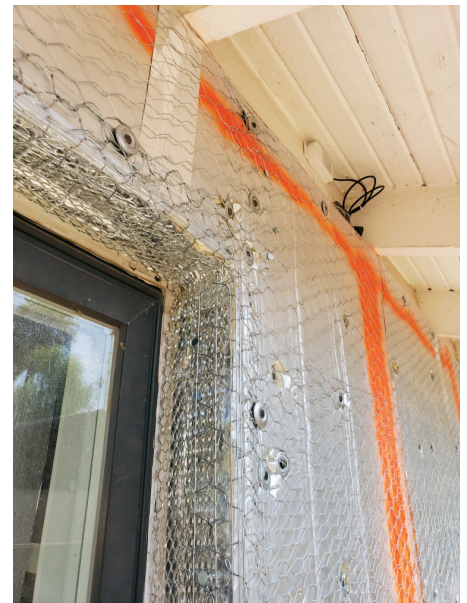
Jamb Detail

Stucco lath wraps around the windows and covers the 2 inches of foil-faced polyisocyanurate rigid foam that was installed over the original concrete block walls.

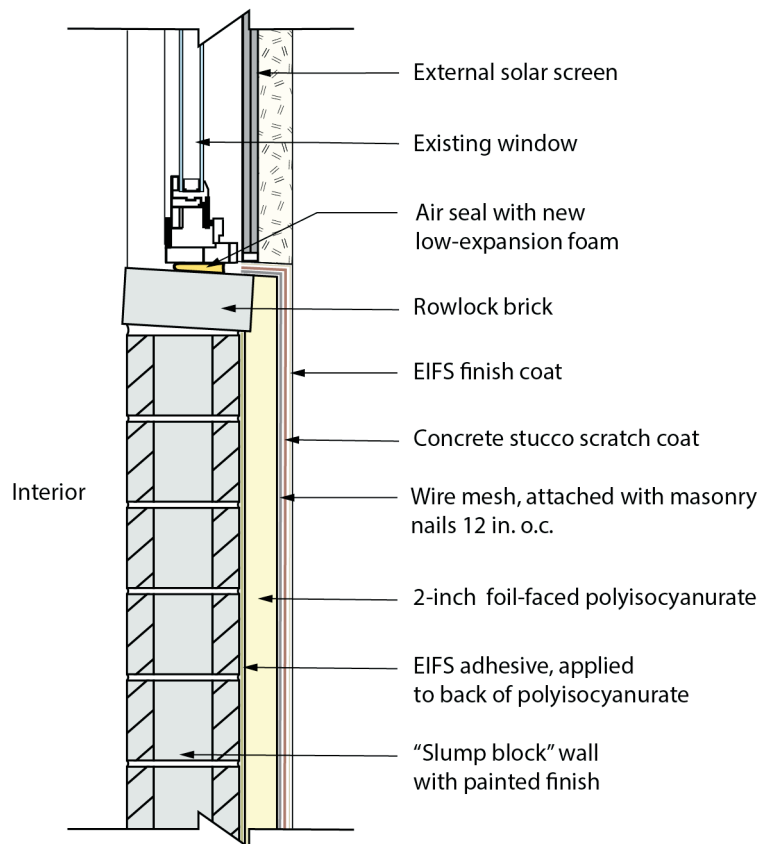
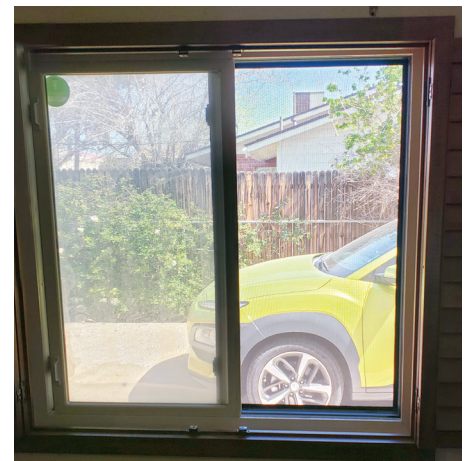
Sill Detail

Solar screens were attached to the exterior of the window frames with Velcro-like attachments to reduce solar heat gain and views into the home while allowing views out.
