Kalamazoo, MI: Kit Home Retrofit

- Name: Kalamazoo Kit Home Re-Siding
- Location: Portage, Michigan
- Layout: 2 bdrm, 1 bath, 1 fl + basement, 1,500 ft²
- Climate: IECC 5B, cold
- Year Built: 1946
- Retrofit Completed: Jan. 2022

Window Retrofit: Kalamazoo, MI

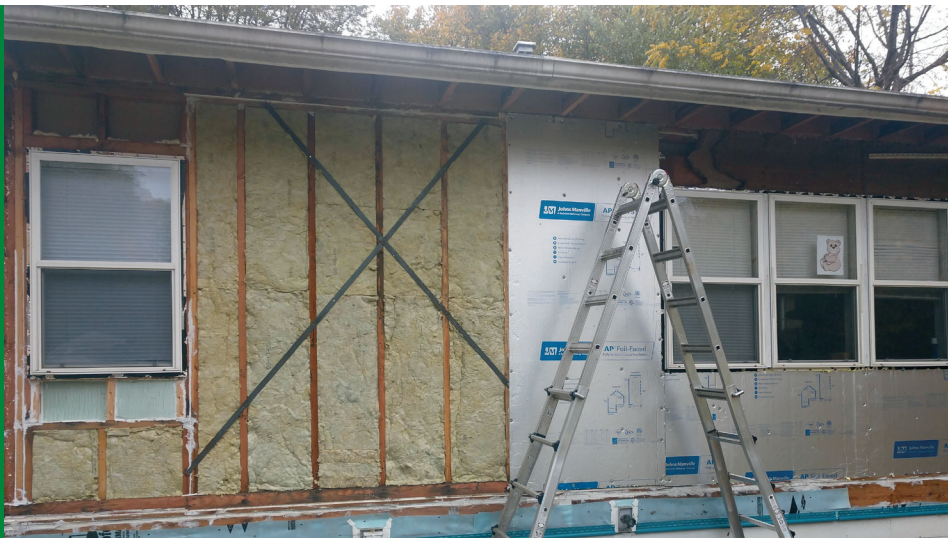
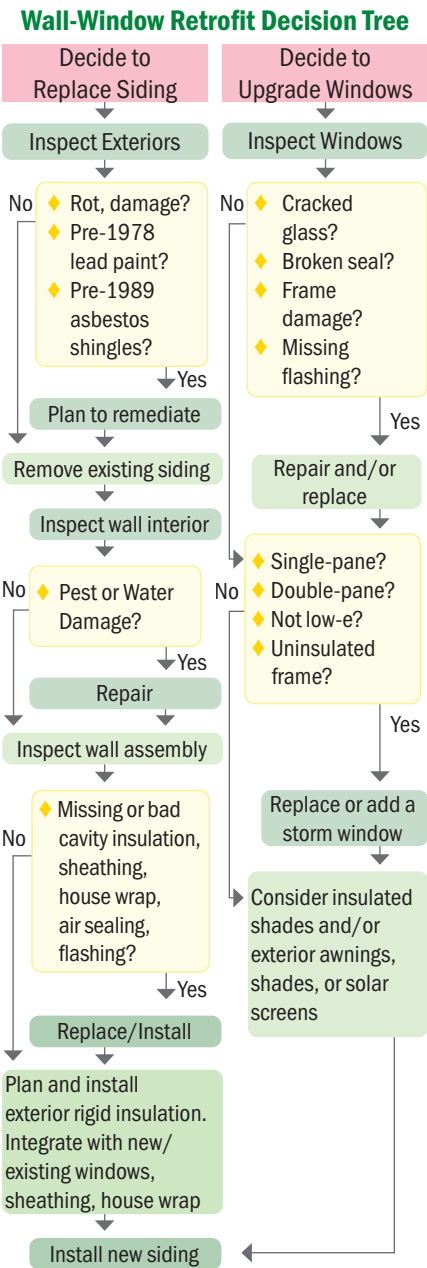
Using the 1-inch space left around the window flanges where the old fiberboard was removed, Tishler carefully installed 1 inch of foil-faced polyisocyanurate. This was the most challenging part of the project said Tishler as it was very time consuming to pull out the old fiberboard and install the new rigid foam without breaking the flanges off the window frames. Tishler seriously considered pulling and replacing the windows with triple-pane windows, which would have made the rigid foam install much easier, allowed for better flashing under the windows, and possibly offered the opportunity to increase the insulation thickness to two inches. However, Tishler had redone all the interior wood window trim after installing the double-pane windows 15 years earlier and didn't want to replace the trim again. As part of the new remodel, he also installed exhaust fans in the bathroom and kitchen to reduce indoor humidity. Tom chose not to replace the 1-inch fiberboard with the 1 inch of rigid foam at the gable ends because the attic was vented and unconditioned.

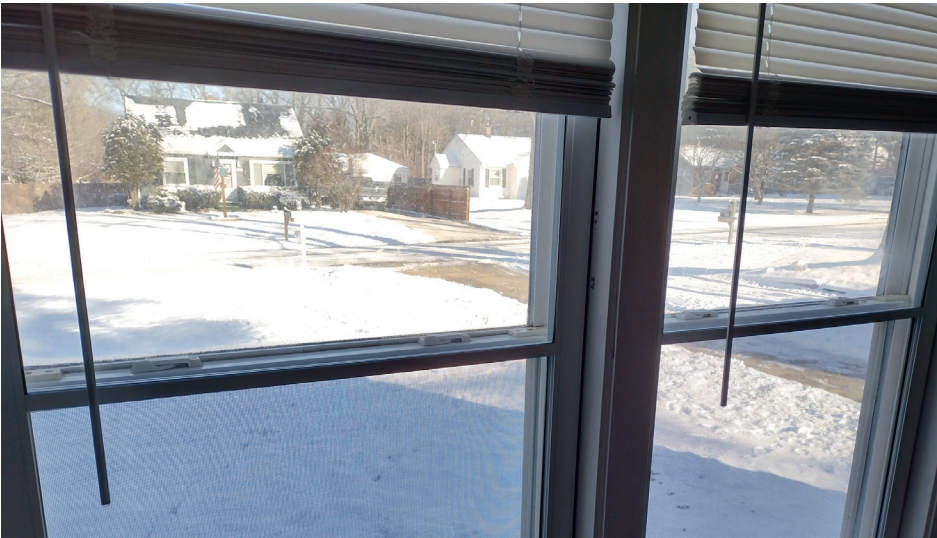
The interior storm windows have white frames that match the trim and are hardly visible once installed but have a very noticeable impact on comfort, making the windows feel warmer and less drafty. Temperature readings showed the interior surface of the glass was 30% warmer, increasing from 40°F to 60°F on a 20-degree winter day when the storm windows were in place. A sound test showed that the storm windows cut exterior noise by 8 decibels, from 56 decibels to 48 decibels, making for much quieter interiors.

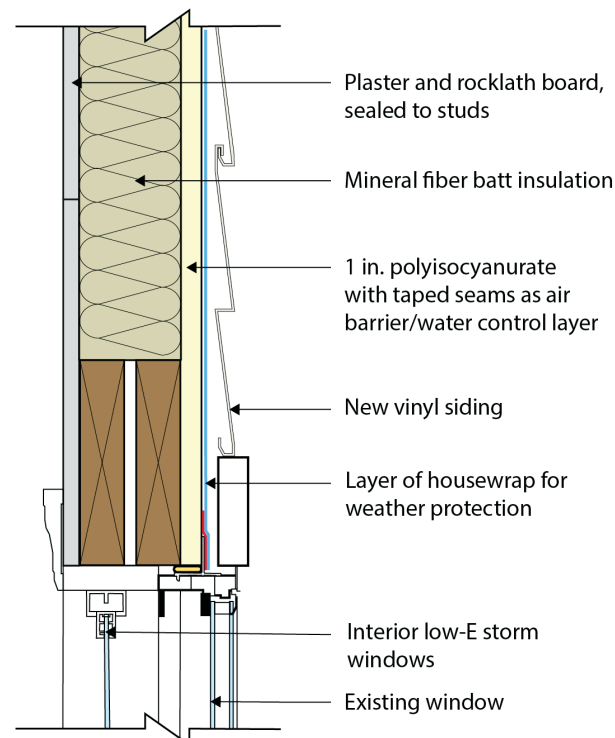
Head Detail

The homeowners love the new storm windows; they have nearly eliminated condensation and have greatly reduced sound transmission. Temperature readings showed the interior surface of the glass was 30% warmer, increasing from 40°F to 60°F on a 20-degree winter day when the storm windows were in place. A sound test showed that the storm windows cut exterior noise by 8 decibels, from 56 decibels to 48 decibels.

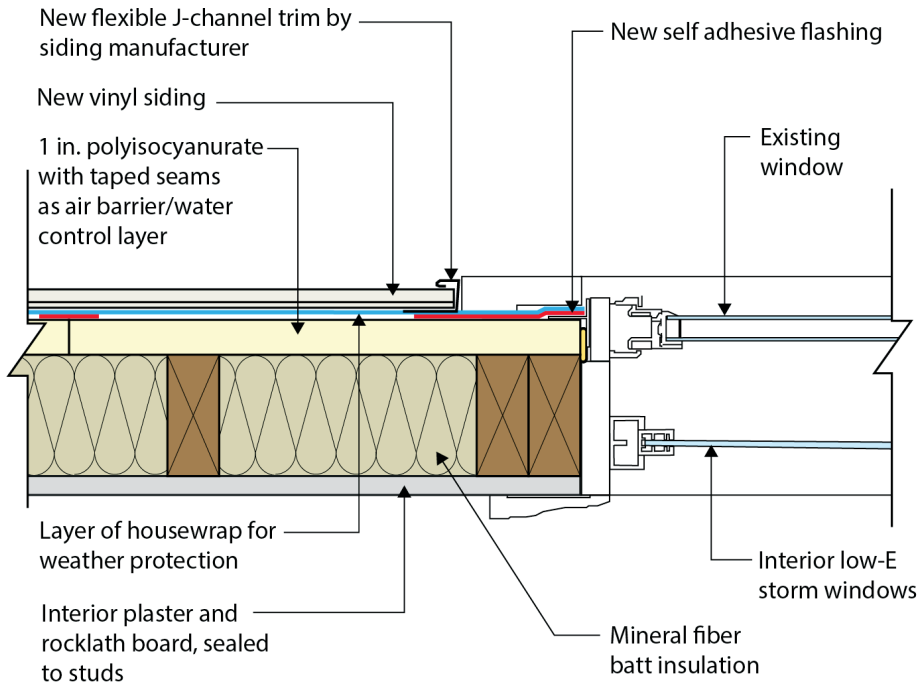
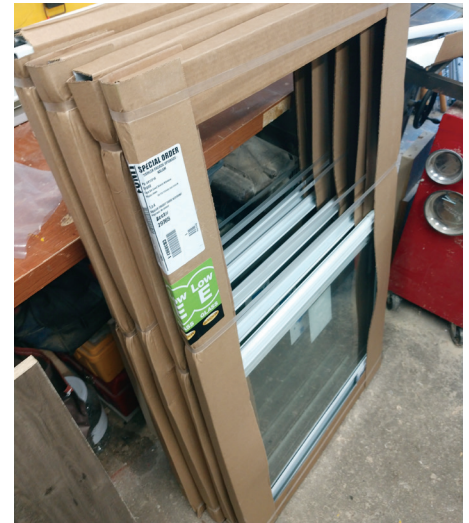
Jamb Detail

The new storm windows have powder-coated aluminum frames that provide a tight seal to the existing window frame. They also have low-emissivity coatings to reduce heat transfer and operable openings that match the single-hung original windows.

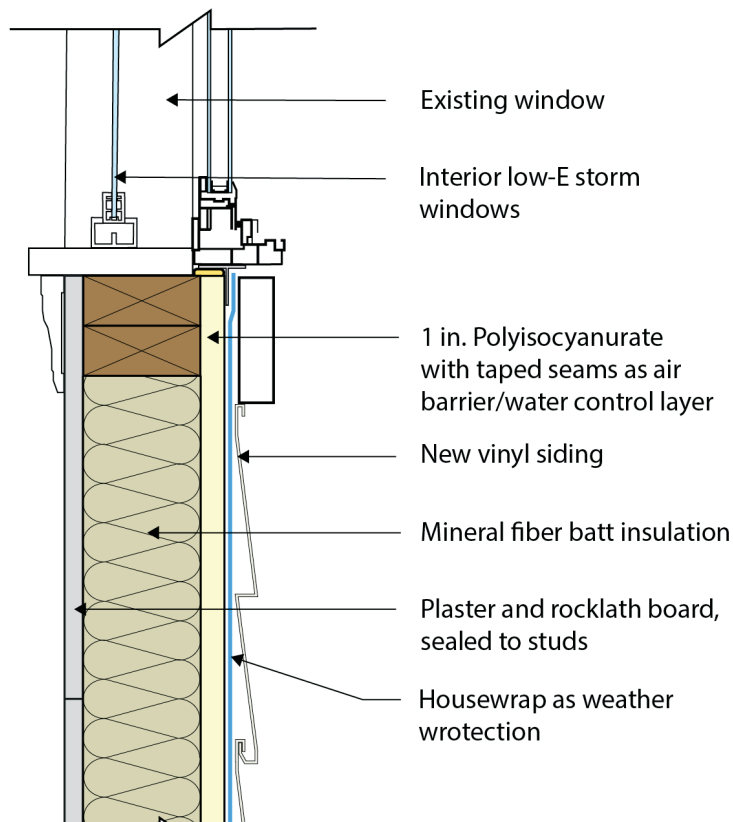
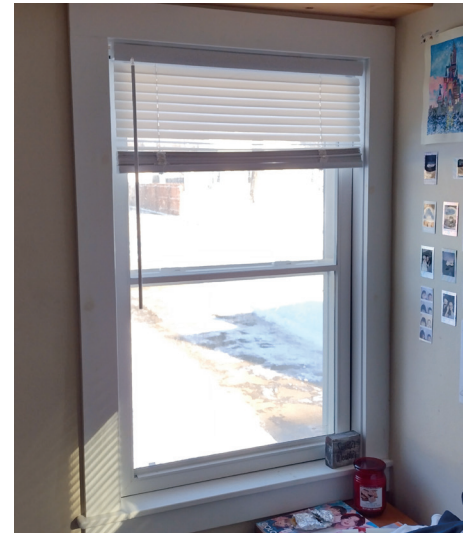
Sill Detail

Each storm window took less than 20 minutes to install and they are nearly invisible once installed. The increase in comfort and decrease in condensation and noise were immediately noticeable.
