Long Island, NY: Vinyl over Stucco

Project Home

- Name: Nassau County Stucco
- Location: Long Beach, NY
- Layout: two-story duplex, 2-bdrm 1 bath per floor; 2,120 ft²
- Climate: IECC 4A mixed-humid
- Year Built: 1920s
- Retrofit Completed: not done

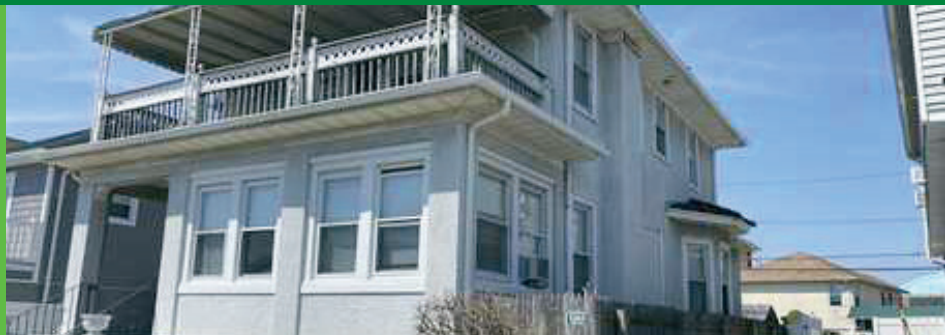
This stucco-covered Long Island home dates back to the 1920s. The retrofit project manager suspected lead paint outside and lack of insulation inside the exterior walls.

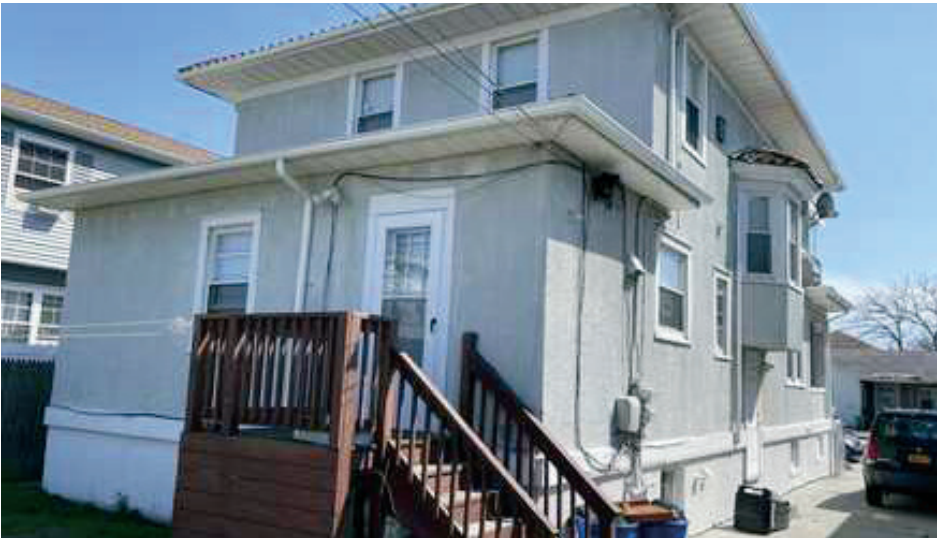
The low-sloped hip-roof design has helped the home survive the hurricanes that travel up the Atlantic Coast and may explain why the original clay tile roofing is still intact. The project team decided to wrap the stucco in taped rigid foam then install vinyl siding over top to encase the lead paint and provide a continuous air, water, and thermal barrier around the home.

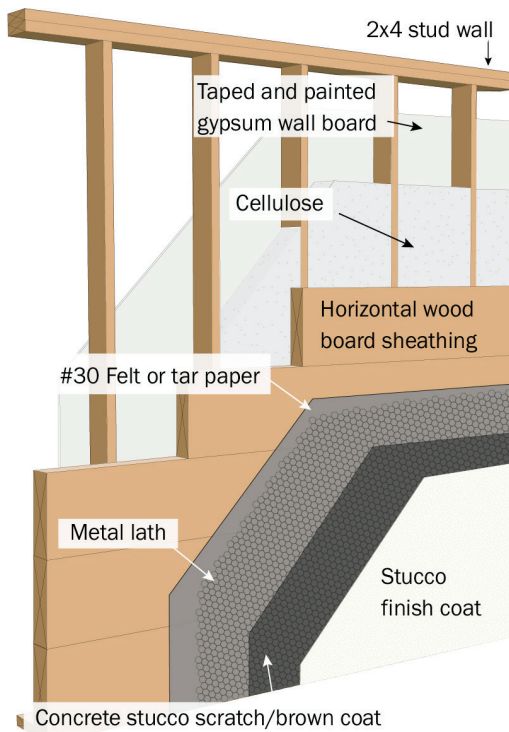
Long Island Pre- and Post-Retrofit Wall Assembly Details

Phoenix	Pre-Retrofit	Post-Retrofit
Vintage	1949	2022
Wall Assembly	2-story stucco. 2x4 16" oc, some mineral wool cavity insulation, two sheets of tar paper, cementitious stucco.	Cover stucco with rigid foam, tape seams to serve as the air- and water-control layer. Instead of furring strips, use 3.5-inch wafer-head screws, through the foam, into the wood sheathing, to attach the vinyl siding.
Windows	All double pane.	Add exterior low-e storm windows.
Other Retrofits	Enclose 2nd-story porch. Add flood gates to crawl space. Install attic venting.	Project not completed.
