Phoenix, AZ: Insulating Concrete Block Walls

Project Home

- Name: Slump Block Home
- Location: Phoenix, Arizona
- Layout: 3-bdrm, 1 bath, 1 fl, 1,980 ft²
- Climate: IECC 2B, hot-dry
- Year Built: 1949
- Retrofit Completed: July 2021

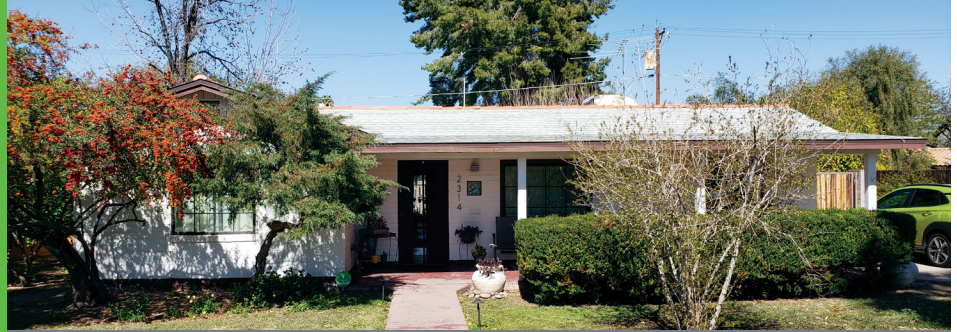
Rigid foam exterior insulation and solar screens were among the energy-saving retrofits to this 1950s concrete block home in Phoenix.

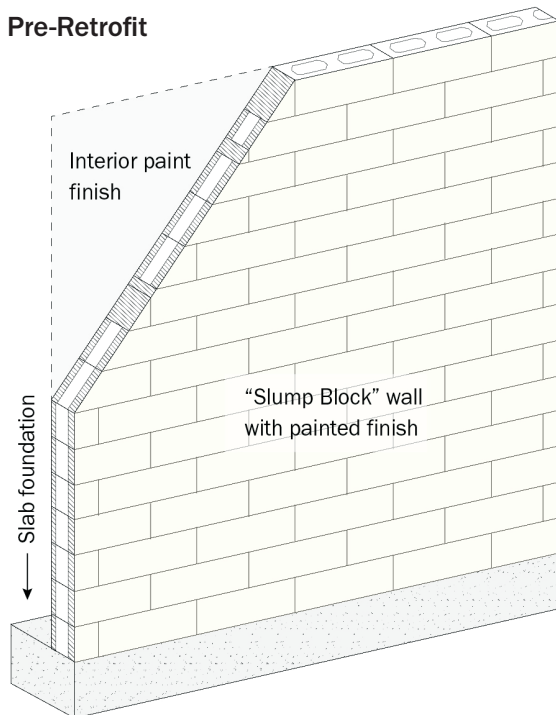
Pre-Retrofit

The original home had no insulation, no exterior siding, no interior framed wall, and no drywall. The entire wall assembly consisted of uninsulated concrete block that was painted on the interior and exterior. In this retrofit, 2 inches of foil-faced polyisocyanurate rigid foam was added to the exterior of the home then covered with metal lath and two-part stucco. The added insulation greatly improved the comfort of the home, especially on the east side of the home where a driveway reflected heat into the home.
