Jackson, MS: Railroad Renovation

Window Retrofit: Jackson, MS

PNNL-SA-173314 • November 2022

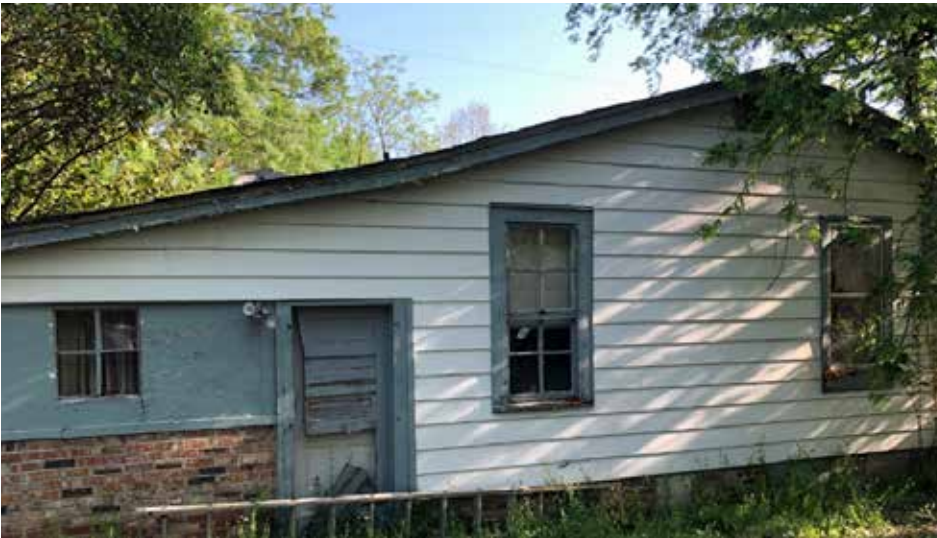
The home's original single-pane metal or wood-framed windows were in poor shape. Some were cracked, several were water damaged. All of the windows were replaced with triple-pane windows. Although the hot-humid climate of Jackson may not warrant high R-value windows for energy savings alone, the home's location near an active railroad line meant the sound-dampening effects of the triple-pane windows would be greatly appreciated.

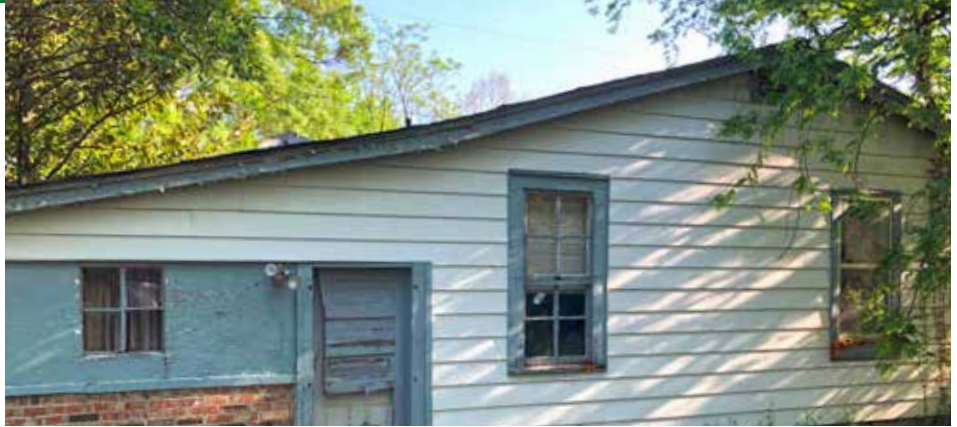
ENERGY STAR Most Efficient triple-pane vinyl-framed windows

This 1950's bungalow in Jackson, Mississippi, needed extensive renovation throughout, including the windows, which were a mix of single-hung wood-framed and fixed metal-framed single-pane clear-glass windows. Some were missing glass, none of the framing was true, and extensive water damage was evident around the frames and sills of most of the windows. The U.S. Department of Energy-supported retrofit included replacing the old windows with ENERGY STAR Most Efficient triple-pane windows. The new windows have vinyl frames, an argon gas fill between the panes, and two layers of low-emissivity coating which together provide an insulation value of $U=0.20$ and a solar heat gain coefficient of 0.18. The windows came with tempered glass, which the big box supplier recommended given the possibility of hurricane-related storms in the region. In addition to the significant improvement in energy efficiency, the windows will also provide significant sound abatement, an important benefit given that the home is located 100 yards from an active railroad track.

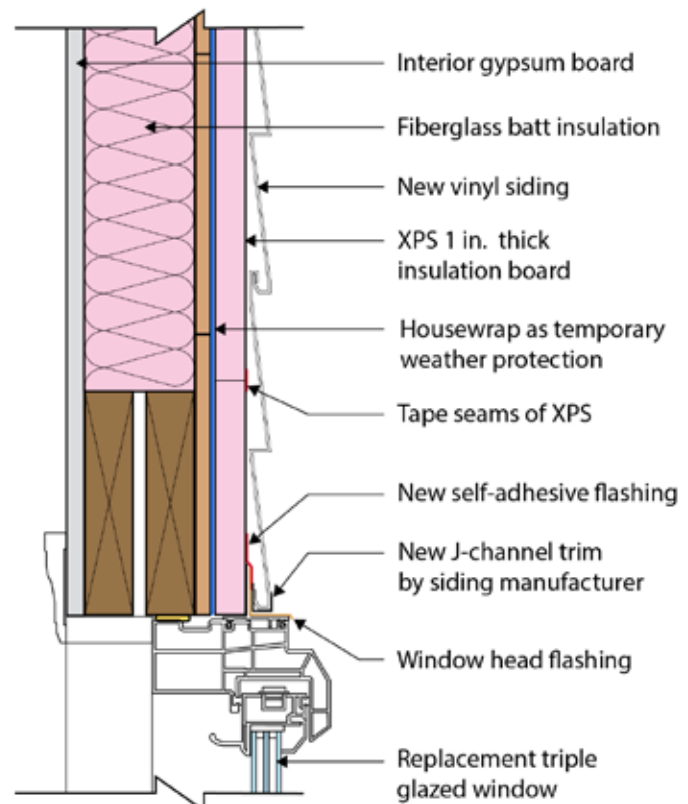
Head Detail

The original windows, an assortment of single- and double-pane metal- and wood-framed windows were in bad shape. All were replaced with triple-pane vinyl-framed windows for energy efficiency and sound abatement. Note, at the bottom of the window, pan flashing is typically installed beneath the sill but tape is not installed over the sill flange.
