Kalamazoo, MI: Kit Home Retrofit

- Name: Kalamazoo Kit Home Re-Siding
- Location: Portage, Michigan
- Layout: 2 bdrm, 1 bath, 1 fl + basement, 1,500 ft²
- Climate: IECC 5B, cold
- Year Built: 1946
- Retrofit Completed: Jan. 2022

Window Retrofit: Kalamazoo, MI

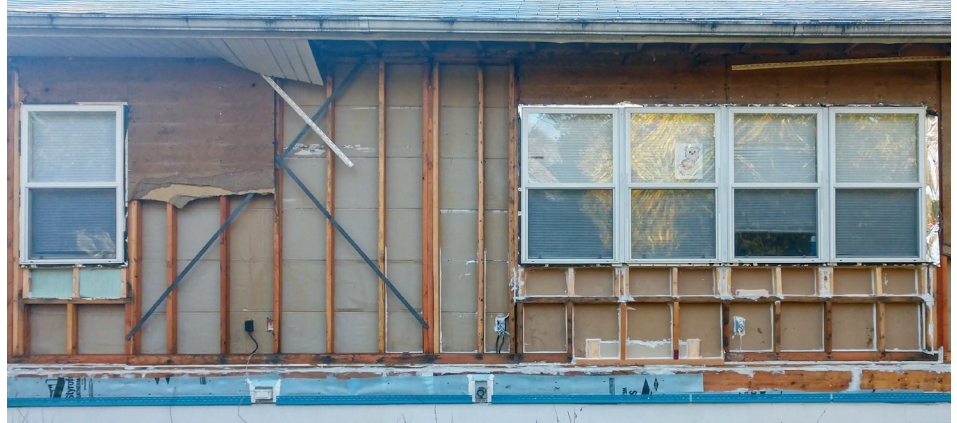
The homeowner/contractor on this home had already begun a retrofit of this 1946 kit home to remove vinyl siding installed in 2005 so he could air seal the walls and install new cavity insulation plus 1 inch of rigid foam topped by new vinyl siding, when he was approached with the possibility of upgrading the windows as well as part of a U.S. Department of Energy wall and window residing retrofit case study. He had already decided against replacing the windows because he had replaced the original single-pane clear-glass windows with double-pane vinyl-framed windows 15 years prior and had then painstakingly installed new interior wood trim around all of the windows. The homeowner realized, however, that after increasing the wall insulation so much, the lower grade windows would feel even more cold and drafty. Wiping down the windows had been a daily chore to reduce ice formation inside the home in winter and water accumulation and mold around the windows the rest of the year. Low-emissivity storm windows were recommended as a retrofit. Powder-coated aluminum storm windows were selected that attached to the interior of the window frames and had openable glass panels.
