# Window Retrofit: Jackson, MS

- Name: Railroad Renovation
- Location: Jackson, Mississippi  
Layout: 3 bdrm, 1 bath, 1 fl, 820 ft<sup>2</sup>
- Climate: IECC 3A, hot-humid
- Year Built: 1955
- Retrofit Completed: June 2022

## Jackson – Windows

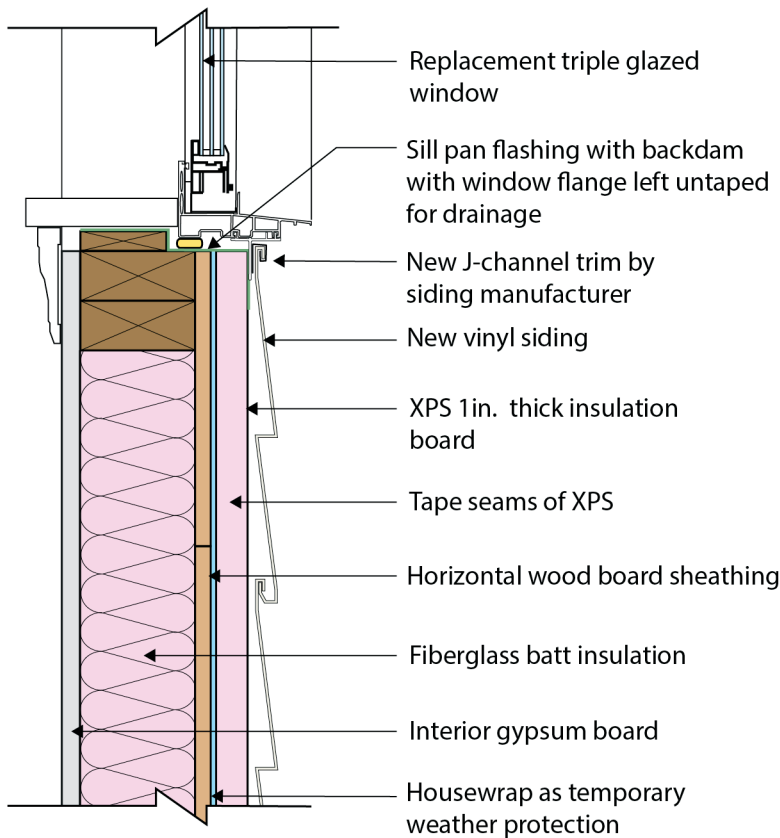
## Sill Detail

The original windows, an assortment of single- and double-pane metal- and wood-framed windows were in bad shape. All were replaced with triple-pane vinyl-framed windows for energy efficiency and sound abatement. Note, at the bottom of the window, pan flashing is typically installed beneath the sill but tape is not installed over the sill flange.
