Investigating Solutions to Wind Washing Issues in Two-Story Florida Homes, Phase 2

C. Withers and J. Kono

*Building America Partnership for Improved
Residential Construction*

April 2015

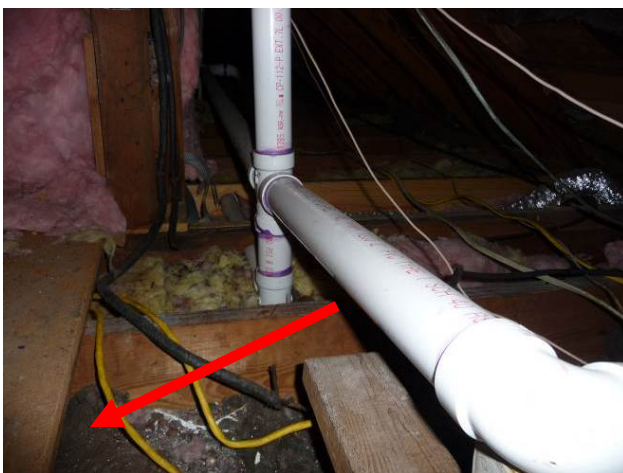
Figure 5. Photo from inside the east attic section at House H36M. The arrow points to the floor cavity opening. Attic vents are out of view on the right.

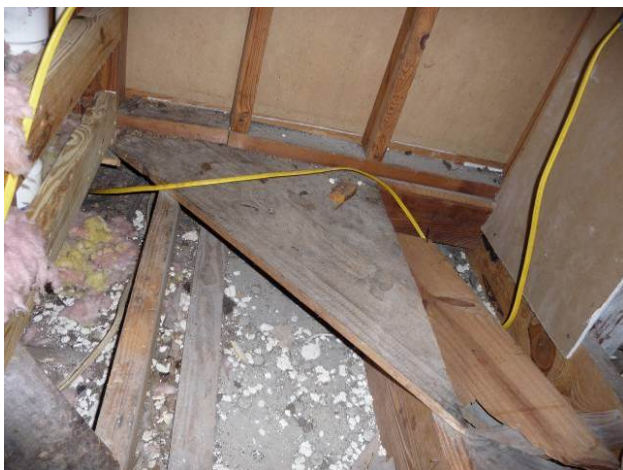
Figure 6. House H36M. View inside an east attic floor cavity section, with uninsulated knee wall area above. Complementary wind washing pathways are located at the other end of the floor cavity in the west attic.

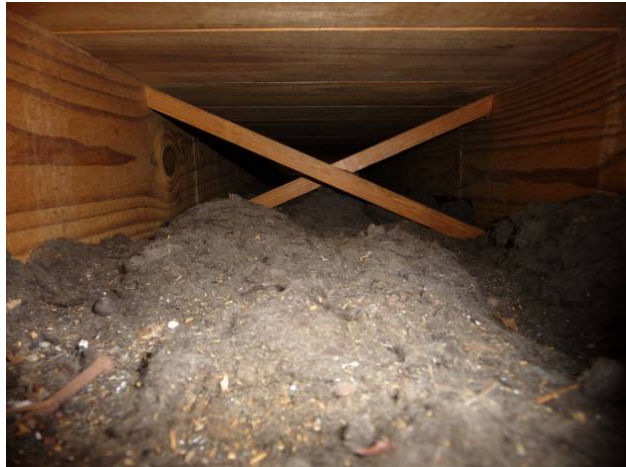
Figure 7. View inside one section of floor cavity from the east attic of House H36M. This floor cavity is wide open to the attic space.

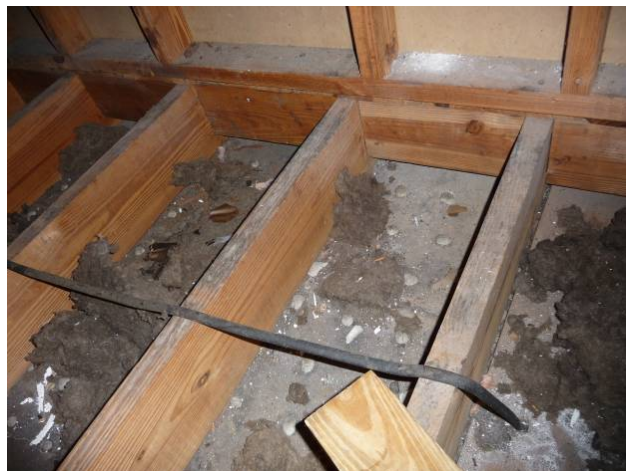
Figure 8. Most of the floor cavity openings from the west attic of House H36M are substantially blocked by frame members positioned between solid floor joists (see close-up in Figure 9).

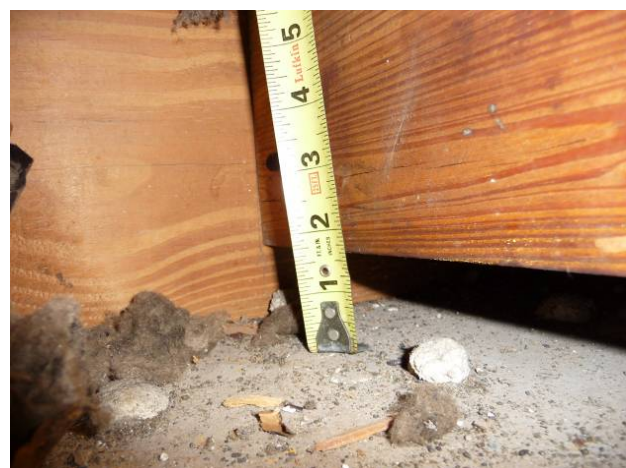
Figure 9. Most of the openings between the attic and floor cavities are blocked by frame members, leaving a 1-⁵/₈-in. gap that occurs continuously. Pieces of original dirty insulation (R-11) have fallen from the roof deck above.

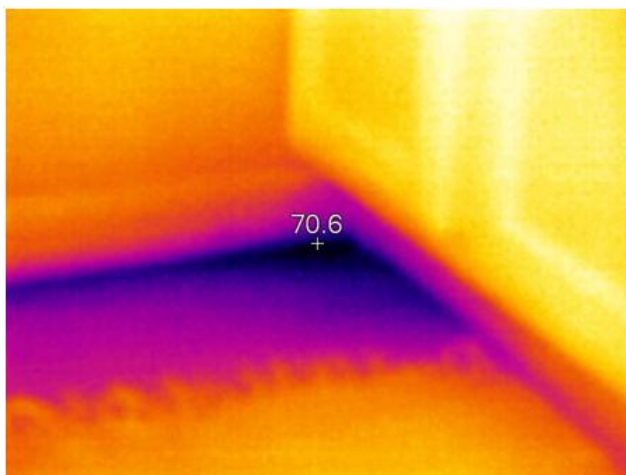
Figure 20. A bathroom floor had relatively cold surface temperatures compared to the heated area around it because of wind washing in the floor cavities below the floor.

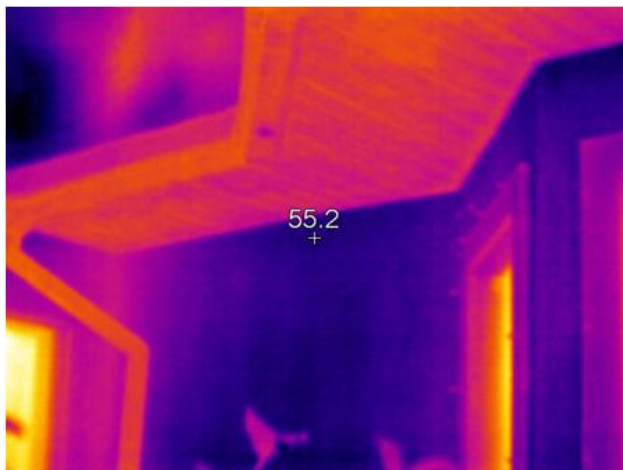
Figure 22. IR image of exterior west-facing wall. The soffit vent area is about 57.8°F.

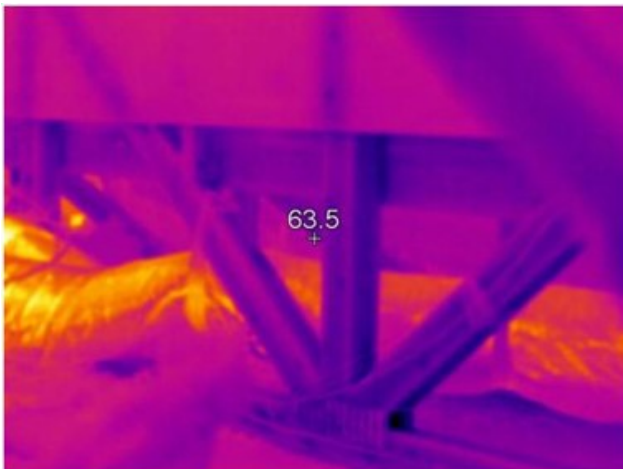
Figure 24. IR image of openings between the east attic and floor cavities near the second-floor bathroom

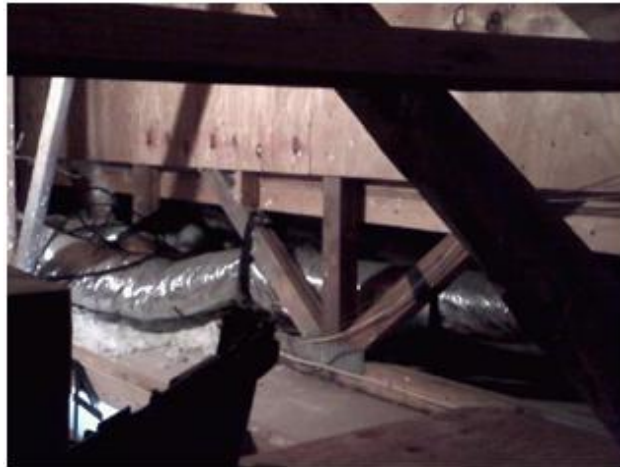
Figure 25. Photo of openings between the east attic and floor cavities near the second-floor bathroom

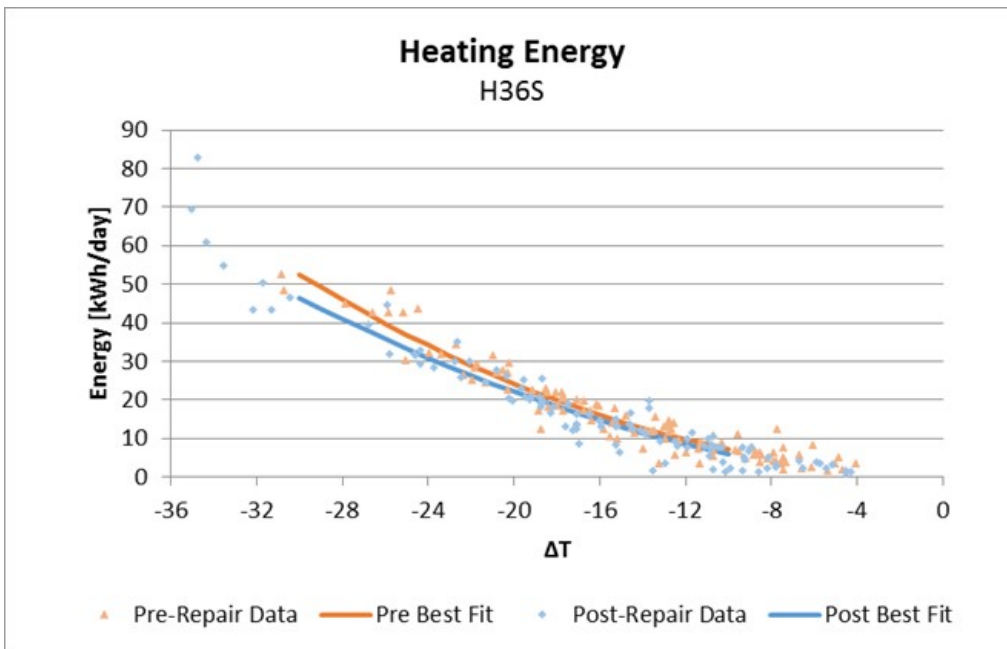
Figure 45. Daily heating energy and daily average dT between outside and inside for House H36S

Table 6 shows the predicted annual heating energy kilowatt-hours before and after repairs along with the annual savings. The savings are shown for only four of the six homes and range from 10.1% to 38.7% with an average of 24.8%. House H47W had inadequate heating weather data to evaluate heating savings. The large negative savings at house H37M appears to be related to a drop in the heating output that developed sometime during the post-repair heating period. Service work was required as reported by the homeowner, but he could not recall the exact nature of the repair. Monitoring data also indicate a drop in the heating performance. The average dT between the return and supply air dropped about 2.3°F in the postheating period compared to the preheating period. A lower supply air temperature indicates less heating was delivered and resulted in a longer runtime to meet load. If this house is left out of the average, the average heating savings is about 6.1 kWh/day (16.1%).

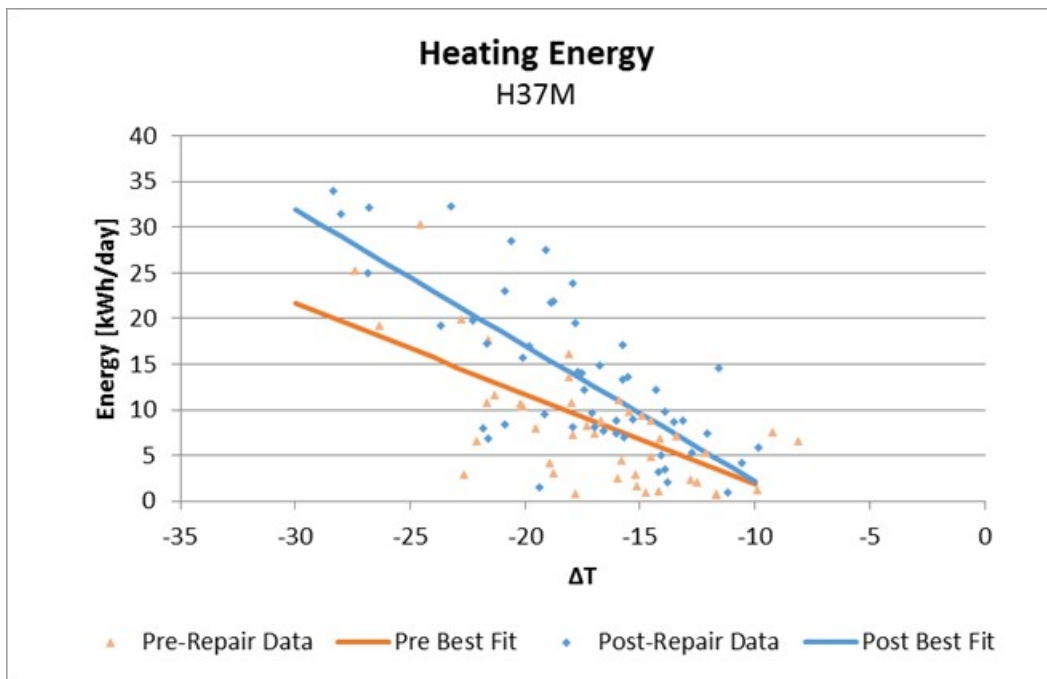
Figure 46. Daily heating energy and daily average dT between outside and inside for House H37M; the post-repair period was period higher because of equipment problem

* Post-repair energy was higher because a refrigerant leak developed during postheating repair period.

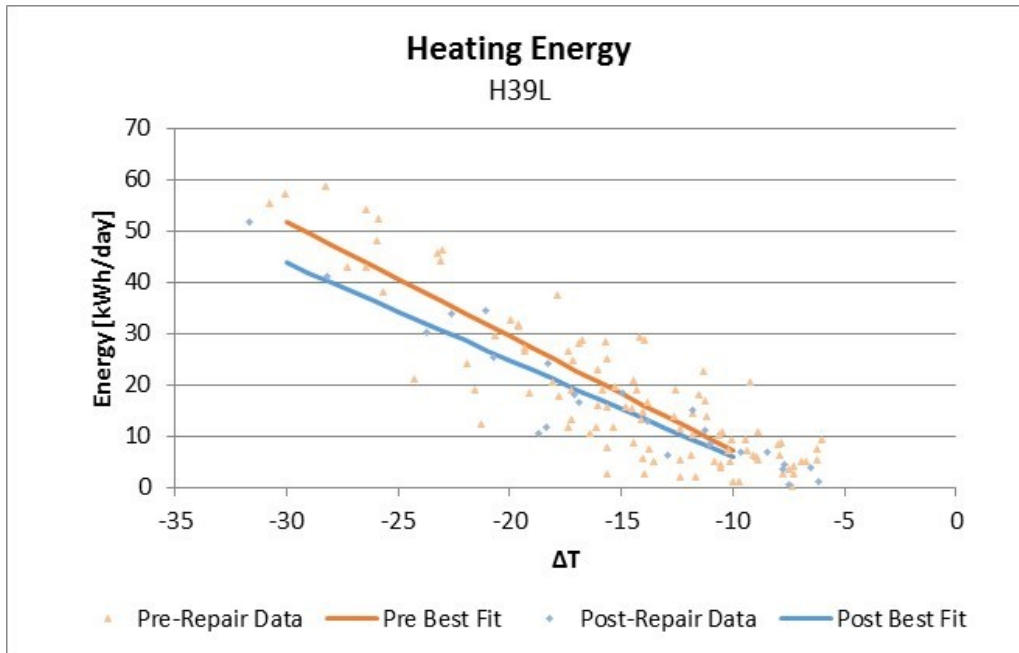
Figure 47. Daily heating energy and daily average dT between outside and inside for House H39L

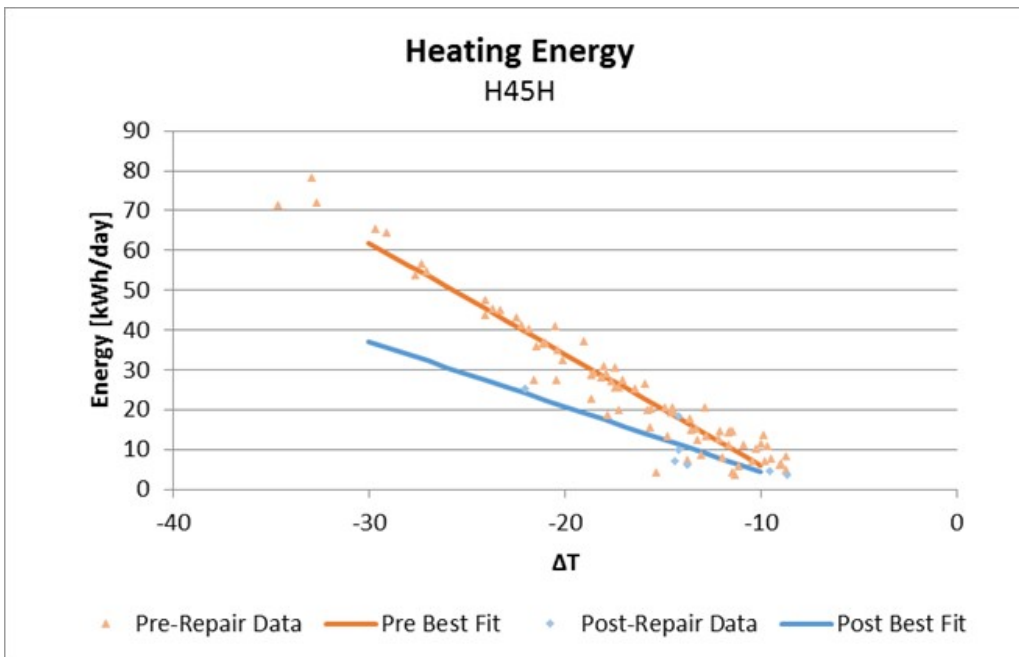
Figure 48. Daily heating energy and daily average dT between outside and inside for House H45H

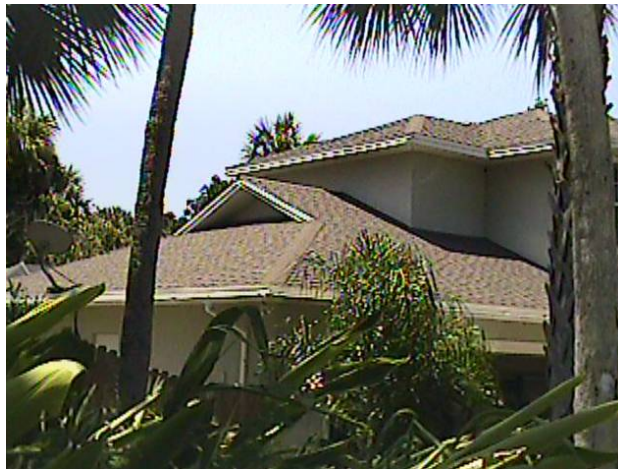
This house, known as H23K, was tested in August 2009 and was considered to have a high wind washing potential. This home is located within a half mile of the Atlantic Ocean, has a vented attic, and had open floor cavities oriented east to west, which readily allowed the predominant east-to-west sea breeze to flow through these cavities. An exterior view of the attic section over the garage on the east side of home is shown in Figures A1 and A2.

Figure A1. East and north sides of House H23K with garage attic adjacent to open floor cavities

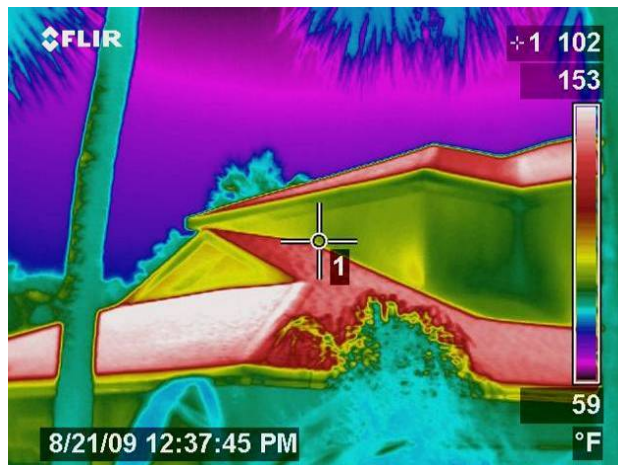
Figure A2. IR image of the house at midday after mostly sunny conditions all morning

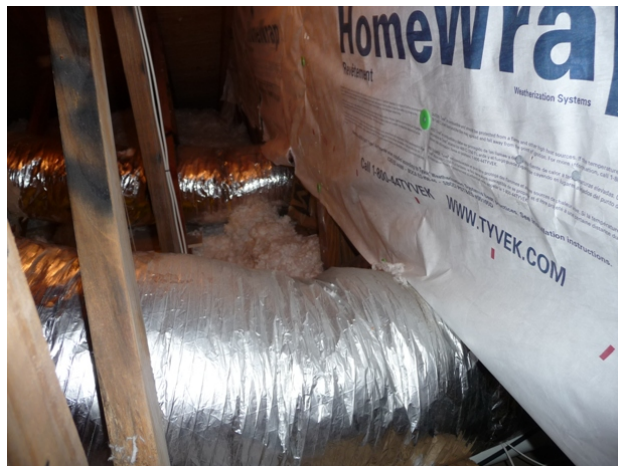
Figure A4. Looking at ducts passing from west attic into an open floor cavity

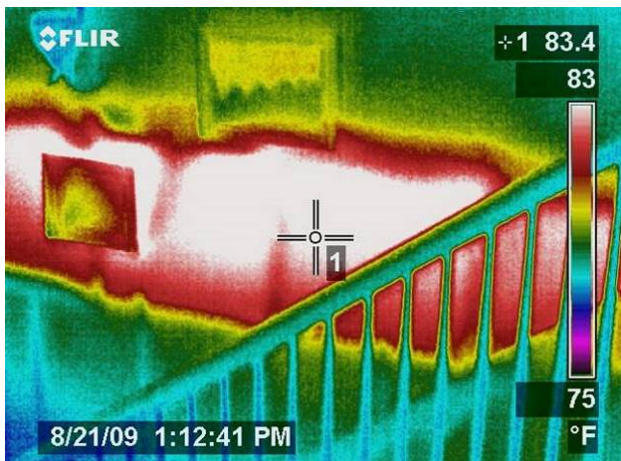
Figure A5. IR image shows where hot attic air has penetrated into the floor cavity that lies behind the stairwell wall.

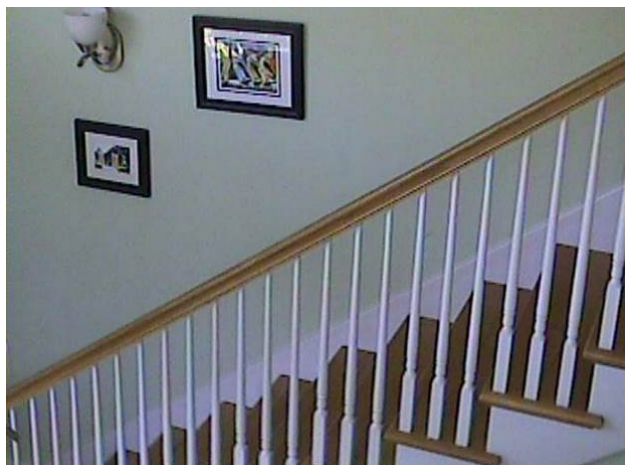
Figure A6. Stairwell where the wind washing thermal impacts is occurring

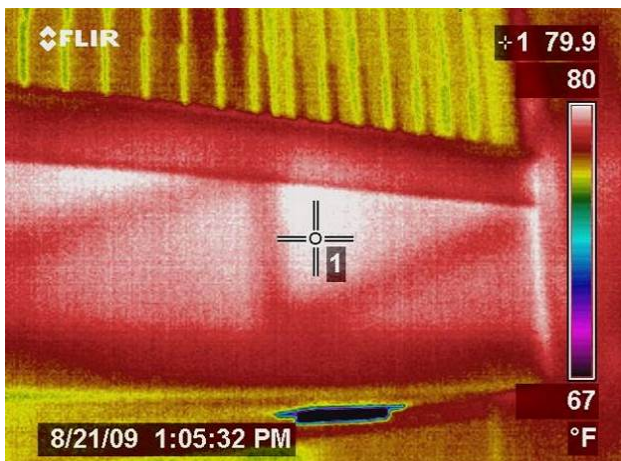
Figure A7. Thermal image of second floor landing. The heat signature indicates flow of attic air far into the interstitial cavities of the house.

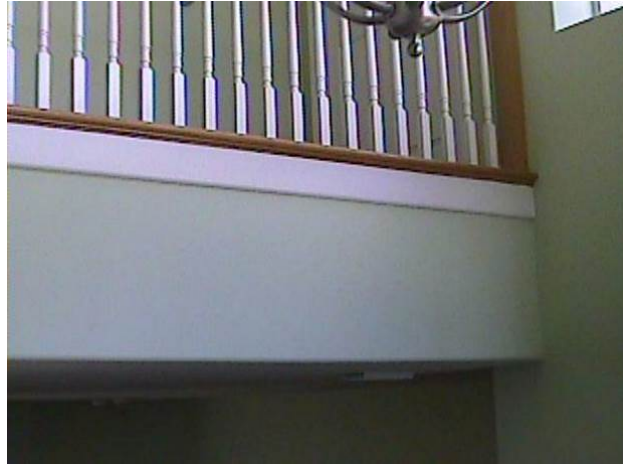
Figure A8. Photo of second-floor landing

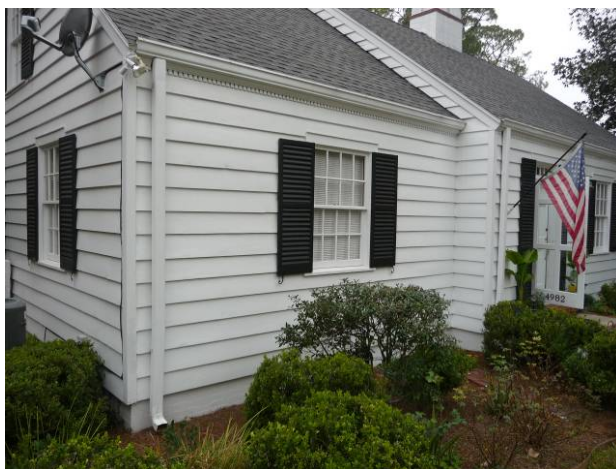
Figure A14. Front northwest corner of 1940s era House H36M. The west attic area is over the room on the northwest corner.

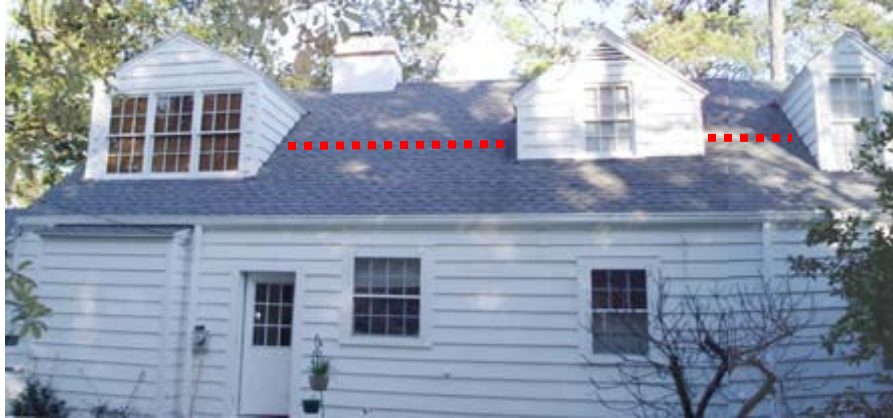
Figure A15. House H36M east back side where the shallow east attic is located. The vertical plane of the knee wall and floor cavity is approximately at the red dashed line.

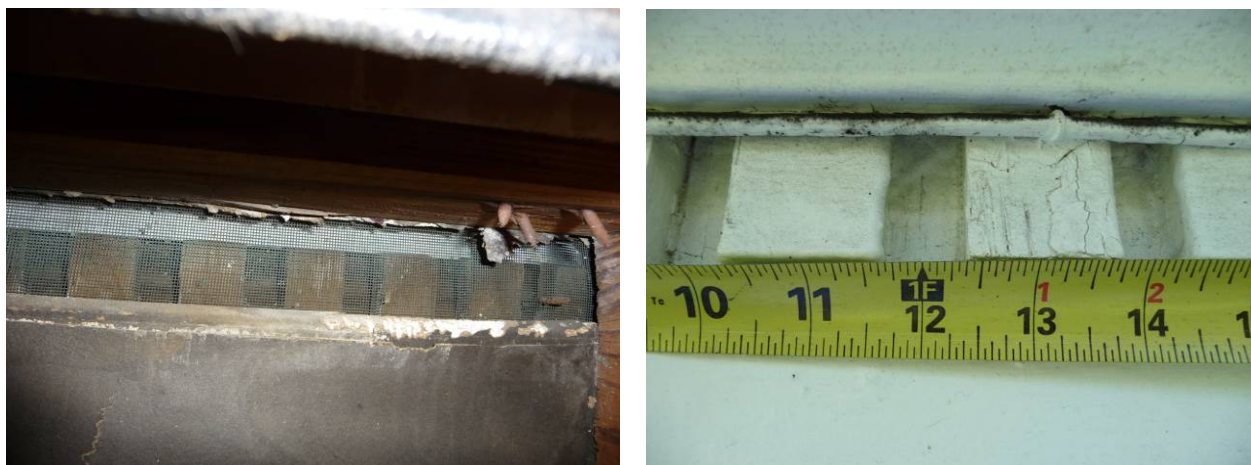
Inspection of attic spaces revealed old, tattered, and filthy R-11 batts fastened to the wood roof deck. Pieces of batt insulation had broken down in some areas and fallen onto the attic floor below as seen in Figure A16. Attic vent openings seen in Figure A17 are more restrictive to wind-induced airflow into the attic space compared to a fully vented soffit. The total venting around the attic was just 1.9 ft² of net free area. If this home had a modern perforated vented soffit with a 1-ft overhang, the total free area of attic venting would be closer to 16 ft². Most of the second-story floor cavity had leak openings into both the east and west attic sections. The floor cavity is compartmentalized between solid wood joists 10 in. high and the pathways to attic varied from about 1-³/₄ in. to 10 in. high. The total accumulative open pathway areas to the west and east attics are 2.1 ft² and 10 ft², respectively. Photos of the nature of the air leak pathways in this home were shown earlier in Figures 5–9 of Section 3.2 of this report.

Figure A17. Dentil style attic venting viewed from inside attic and from outdoors. Venting is located along both east and west attic floor perimeters and has an insect screen on the attic side.

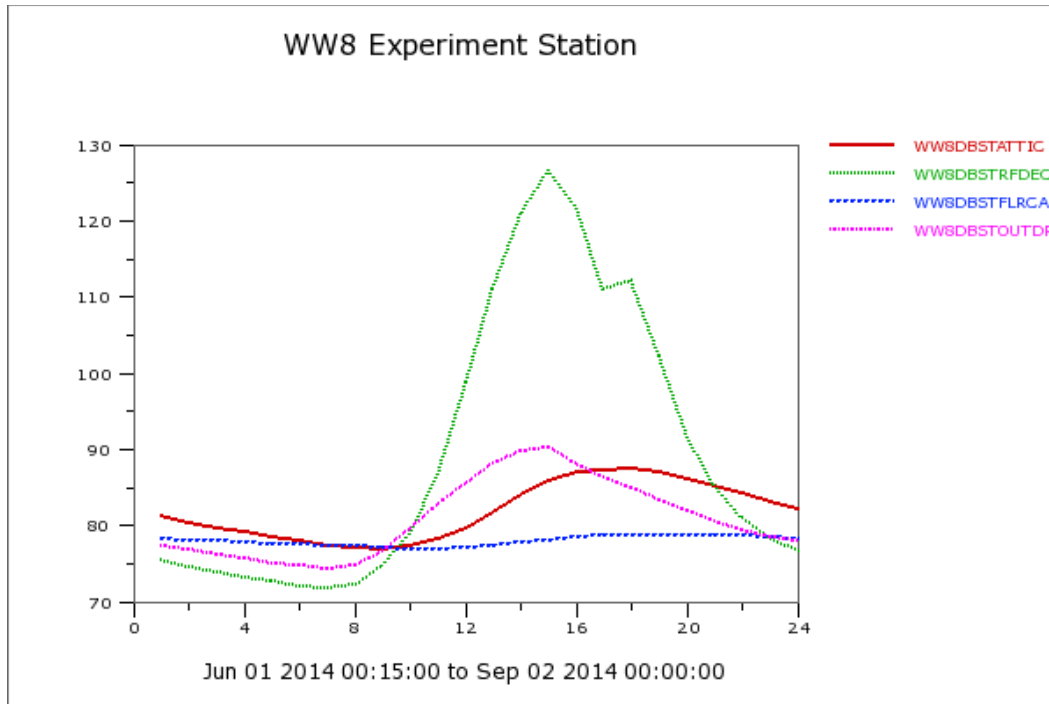
Original construction plans were available for this home. During the original construction, the primary thermal barrier was the R-11 batt insulation located at the roof deck just under an asbestos shingle roof. The roof deck insulation remained over the years and significantly limited the heat transfer into the attic during the summertime. Figure A19 shows a composite plot of outdoor, attic and floor cavity temperatures ($^{\circ}\text{F}$) for all summer days from June 1 to September 1, 2014. This is during the post-repair period. Red is the attic space temperature, green is the attic roof deck temperature between the plywood and the deck insulation, blue is inside the floor cavity, and pink is the outdoors. These data show that the hottest temperatures in the lower attic

area near the floor cavity averaged only about 87°F (3°F cooler than the peak outdoor temperature), even though the roof deck temperature peaked at about 125°F. This post-repair profile is very similar to the pre-repair profile (shown previously in Figure 43). Even the floor cavity temperature was about the same, indicating very little driving force of attic air into the cavity.

Figure A19. Daily composite profile of outdoor and attic temperatures during the summer period

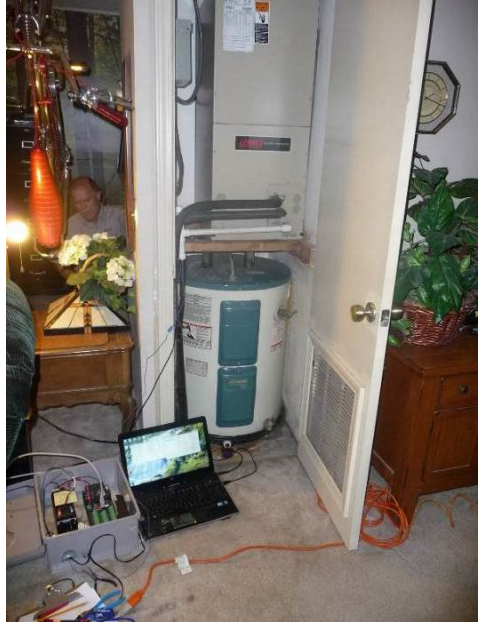
A significant return duct leak (10.4% of total flow) provided a large mechanical driving force that pulls air from the garage attic into the floor cavity and then down into a leaky return plenum closet when the AHU is operating. The return plenum closet, located on the first floor, can be seen in Figure A22 with the door open. Figure A23 shows an upward-looking view of closet ceiling pathways to the floor cavity above. The clearance between the closet walls and the AHU was so small that this view was possible only by squeezing a camera into the space to take photos. Creating a good air barrier at the leaky floor cavity was especially important because there was large return duct leakage from the floor cavity that could not be sealed without tearing out the AHU or other ceiling areas around the closet. (Current Florida code requires adequate clearance around the AHU and adjacent walls.)

Figure A22. This closet operates as a return plenum (shown with door open during data acquisition system installation). A data logger can be seen on the floor next to the laptop.

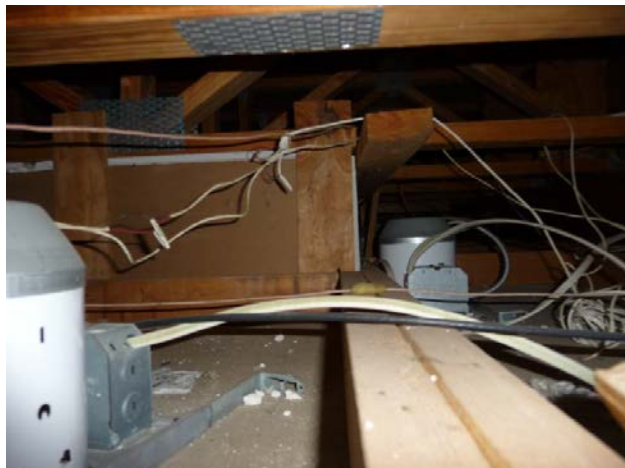
Because of its elevated location beside a nearby lake, this house has good exposure to winds from the south, east, and west. Inspection of attic space above the master bedroom on the west side of house revealed 0.3 ft² of openings between the second-story floor cavity and the attic. During inspection, strong northeasterly winds around 15 mph resulted in noticeable airflow through the floor cavity. A short video and photo image were made showing a piece of paper readily blowing from the second-story floor cavity into the west attic as a result of a strong northeasterly wind blowing into the east attic. Figure A26 shows the paper at the west leakage area around a duct penetration. Inspection of the east attic space above the garage revealed 9.2 ft² of openings between second-story floor cavity and the attic (Figure A27 and A28).

Figure A28. View from garage attic into the dropped kitchen ceiling with floor cavity above

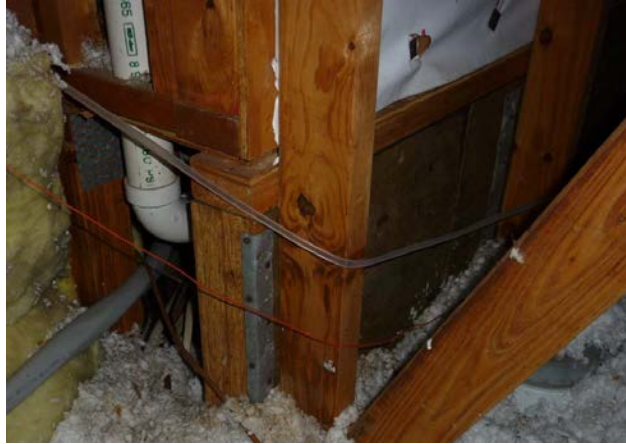
Figure A29. Corner of floor cavity with an air pathway around wire and plumbing penetration and a large area on the right side effectively blocked by plywood
