## Window Retrofit: Kalamazoo, MI

#### Kalamazoo - Windows

Kalamazoo Project	Windows
Upgrade	Install interior low-e storm windows
Number of Windows Upgraded	12
Planned Material Cost	\$0
Planned Labor Cost	\$0
Total Planned Cost	\$0
Added Upgrade Material Cost	\$1,594
Added Upgrade Labor Cost	\$250 <sup>1</sup>
Upgrade Incremental Cost	\$1,844
Total Project Cost with Upgrades	\$1,844
<sup>1</sup> Estimated labor.

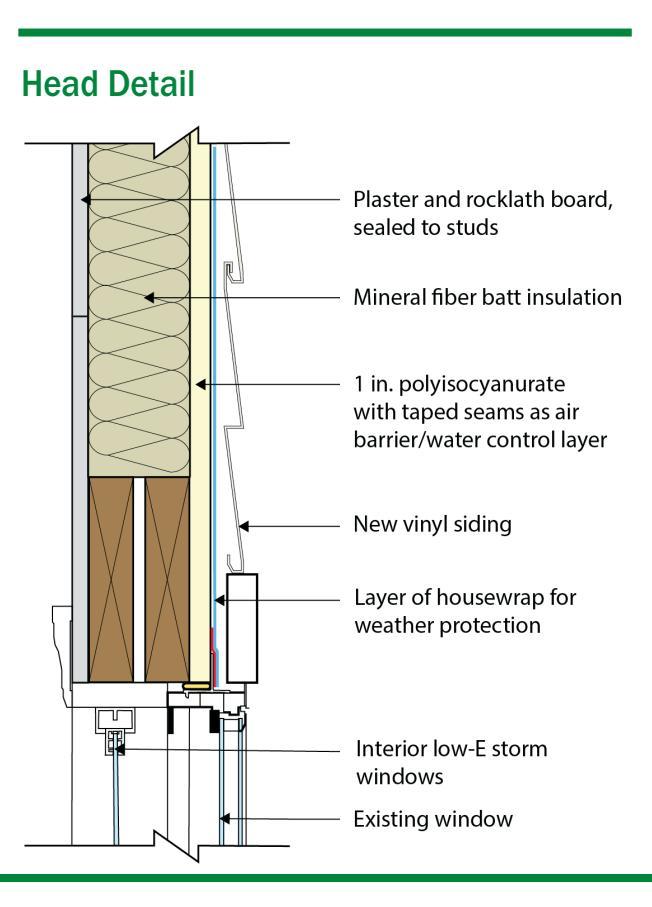
The homeowner/contractor on this home had already begun a retrofit of this 1946 kit home to remove vinyl siding installed in 2005 so he could air seal the walls and install new cavity insulation plus 1 inch of rigid foam topped by new vinyl siding, when he was approached with the possibility of upgrading the windows as well as part of a U.S. Department of Energy wall and window residing retrofit case study. He had already decided against replacing the windows because he had replaced the original single-pane clear-glass windows with double-pane vinyl-framed windows 15 years prior and had then painstakingly installed new interior wood trim around all of the windows. The homeowner realized, however, that after increasing the wall insulation so much, the lower grade windows would feel even more cold and drafty. Wiping down the windows had been a daily chore to reduce ice formation inside the home in winter and water accumulation and mold around the windows the rest of the year. Low-emissivity storm windows were recommended as a retrofit. Powder-coated aluminum storm windows were selected that attached to the interior of the window frames and had openable glass panels.

The homeowners love the new storm windows; they have nearly eliminated condensation and have greatly reduced sound transmission. Temperature readings showed the interior surface of the glass was 30% warmer, increasing from 40°F to 60°F on a 20-degree winter day when the storm windows were in place. A sound test showed that the storm windows cut exterior noise by 8 decibels, from 56 decibels to 48 decibels.

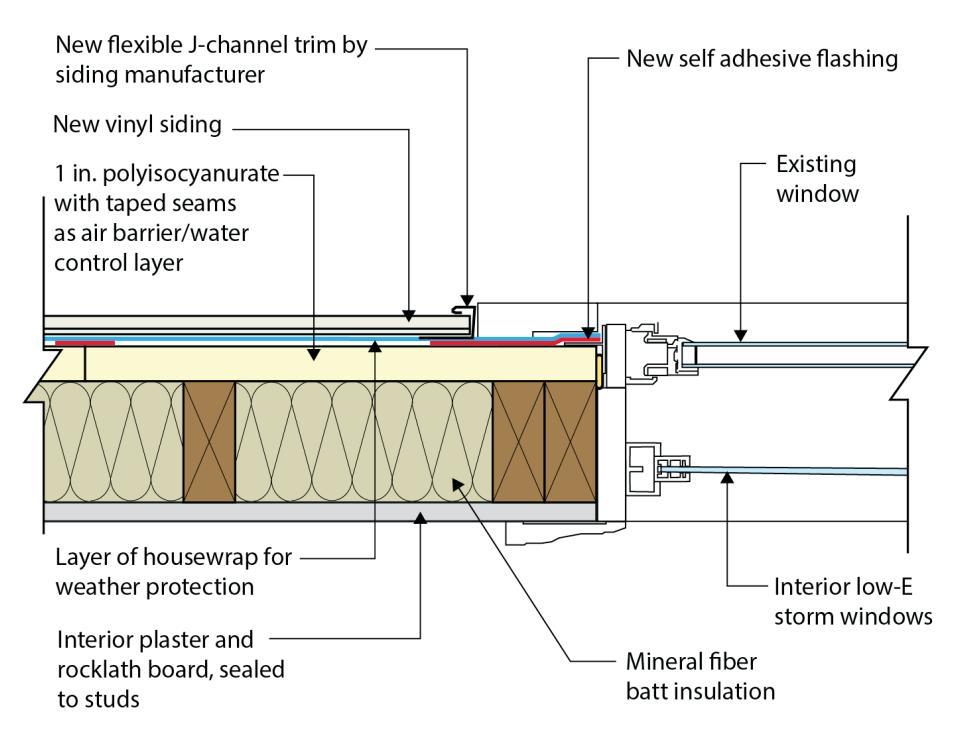
#### Jamb Detail

The new storm windows have powdercoated aluminum frames that provide a tight seal to the existing window frame. They also have low-emissivity coatings to reduce heat transfer and operable openings that match the single-hung original windows.

For the head and sill details, the view is from the side and the interior of the home is to the left of the wall. For the jamb detail, the view is from the top and the interior of the home is below the wall.
