DOE CHALLENGE HOME CASE STUDY

**e2 Homes** Winter Park, Florida

- Name: Wilson Residence
- Location: Winter Park, FL
- Layout: 4 bedrooms, 4 baths
- Conditioned Space: 4,305 ft<sup>2</sup>
- Completion: May 2012

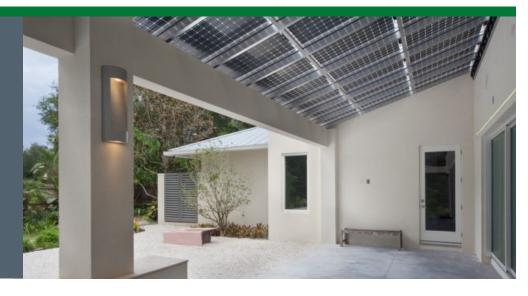
All of the 962-ft<sup>2</sup> porch roof is comprised of solar panels with a 13.4-kW solar array system. The 69 panels don't sit on top of the roof; they are the roof. The completely watertight structure allows about 15% of natural light to filter through the panels, lighting the space below. The panels are dual surface meaning they can produce power from any sunlight reflected up onto their lower surface, for up to 30% greater than rated power production. All wiring is hidden within the canopy's aluminum support beams.

With the home designed for maximum energy and water conservation, the 13.5-kW photovoltaic system is now the appropriate last step for zero net-energy performance. Rather than mounting the 69 solar panels on the roof, the solar installer fit them together to form a watertight structure that literally is the roof of the home's 962-ft<sup>2</sup> porch. The 195-Watt solar panels are bifacial, meaning they can generate some electricity from reflected light that hits the bottom surface of the panels. The panels also permit about 15% of the daylight to filter through them, lighting the porch area beneath. The hybrid inverter converts the panel-produced direct current power into a utility-compatible alternating current, using a unique technology that overcomes the limitations of traditional central string inverter systems but at a much lower cost than micro-inverter systems.
