Building America Case Study Technology Solutions for New and Existing Homes

Interior Foundation Insulation Upgrade—Minneapolis Residence

Minneapolis, MN

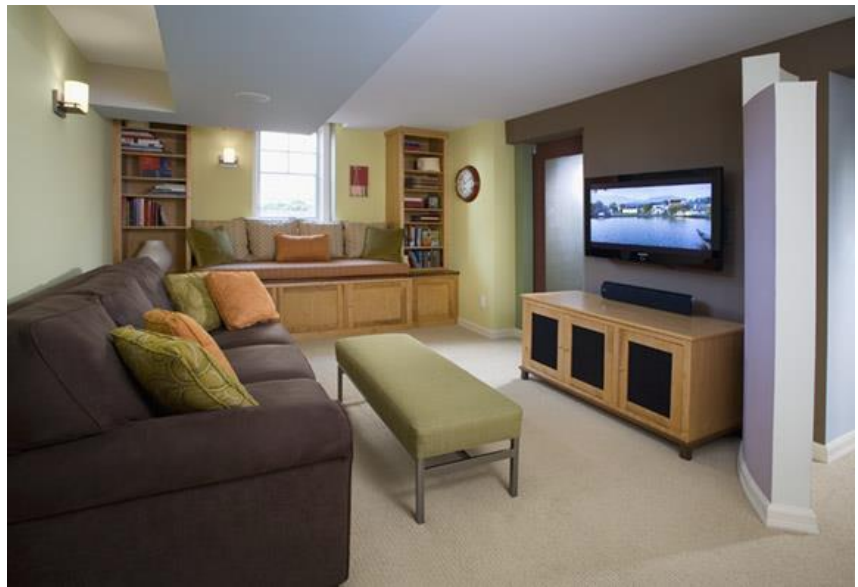
Photo showing finished basement space. Extensive moisture management and insulating efforts result in a warm, dry living space.
