## 2021 IECC Climate Zone 3C: Unvented Attic, 2x6 Wall, Monolithic Slab on Grade

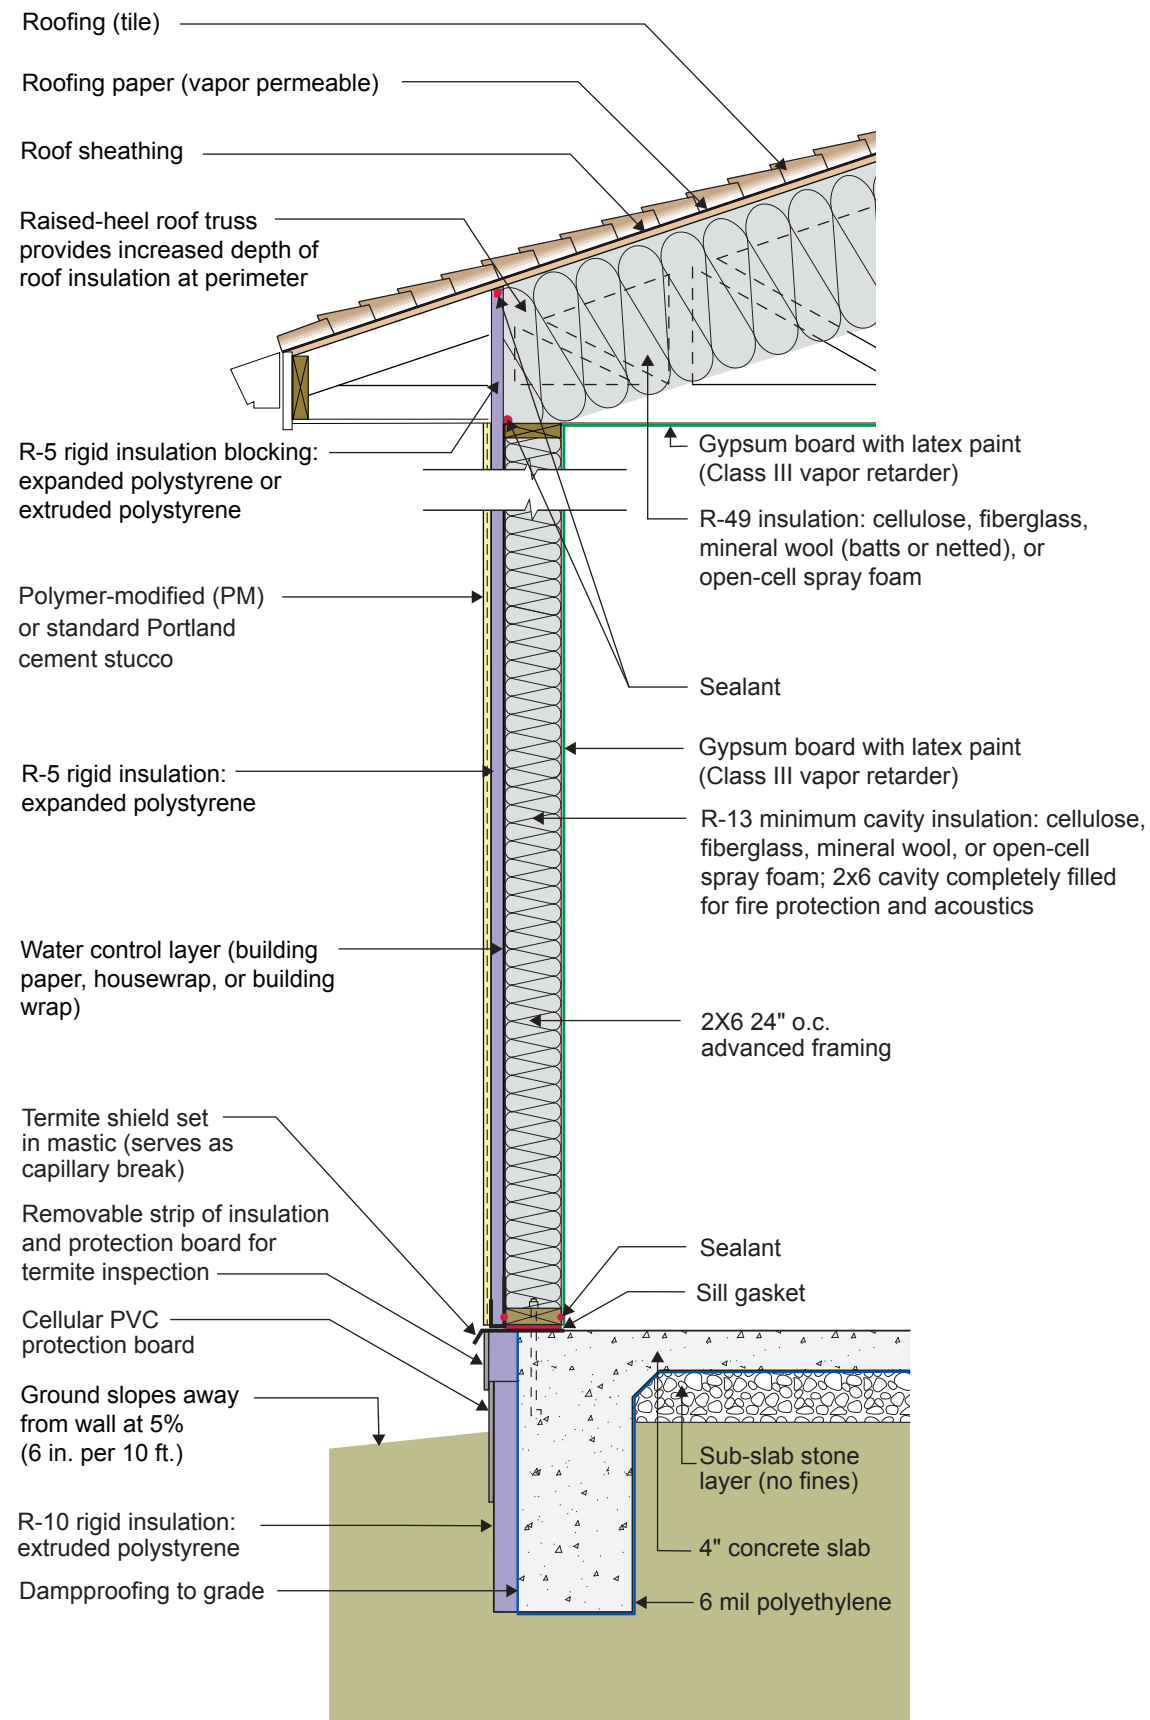
## 2021 IECC Climate Zone 3C: Unvented Attic, 2x6 Wall, Monolithic Slab on Grade

- The insulation in this unvented attic is located on the underside of the roof sheathing. With tile roofing and vapor-permeable roofing paper, no venting or vapor diffusion ports are required for this roof assembly. If the roofing material were shingles, vapor diffusion ports would be needed. Unvented attics are more resistant to entry of embers from wildfires.

- The purpose of the rigid foam insulation on the exterior of the wall is to resist inward vapor drive from the absorptive stucco cladding. This wall has no structural sheathing. Instead, it has metal bracing (not shown) for racking resistance.

- The water control layer in the wall assembly is installed behind the rigid insulation. Drainage occurs between the water control layer and the back side of the rigid insulation.

- The wall is framed with 2x6 24" o.c. advanced framing as it uses less board footage (volume of wood framing) than standard 2x4 16" o.c. framing and therefore is less expensive in material cost. It is also less expensive in labor (25% fewer framing members) and is faster to assemble. Although the code allows for 2x4 framing and lower R-value cavity insulation, the use of advanced framing and the associated cost savings more than offset the increase in the cost of cavity insulation (this of course depends on relative price fluctuations in labor and materials).

- Although the minimum R-value of the insulation in this wall is R-13 per the IECC, fire code may require the entire cavity to be filled, likely resulting in a higher R-value for a 2x6 wall.

- A class III vapor retarder (latex paint) is used on the interior surface of the walls and ceiling instead of a vapor barrier. This allows drying to the interior. Avoid vinyl wallpaper and oil-based paint or coatings in Climate Zone 3. These wall coverings are vapor impermeable and increase the risk of condensation within the wall.

- The rigid insulation on the exterior of the monolithic slab has a removable strip to facilitate termite inspection.
- The entire monolithic concrete slab should have a polyethylene vapor barrier wrapping the underside of the slab and footing to control capillary uptake. The polyethylene should extend upward from the bottom of the footing to grade on the exterior.
